**Engine Failure  
Analysis Manual**

# **STIHL ENGINE FAILURE ANALYSIS MANUAL**

This manual has been designed as an aid to the servicing dealer in diagnosing why an engine has failed. We have attempted to include as many examples as possible, but there are probably some we have missed. Perhaps as these come to our attention we can include them in future editions.

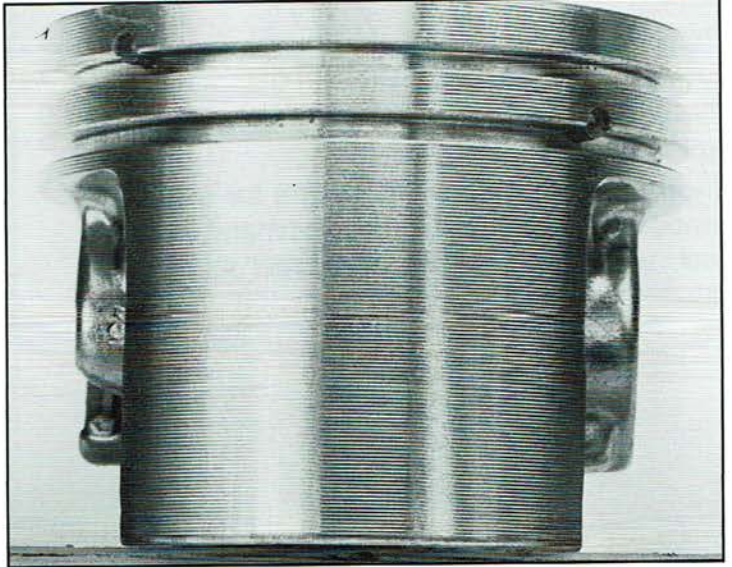
Photo No. 1

Subject: **NEW PISTON**

Observation: Intake side – note machine marks, use for reference.

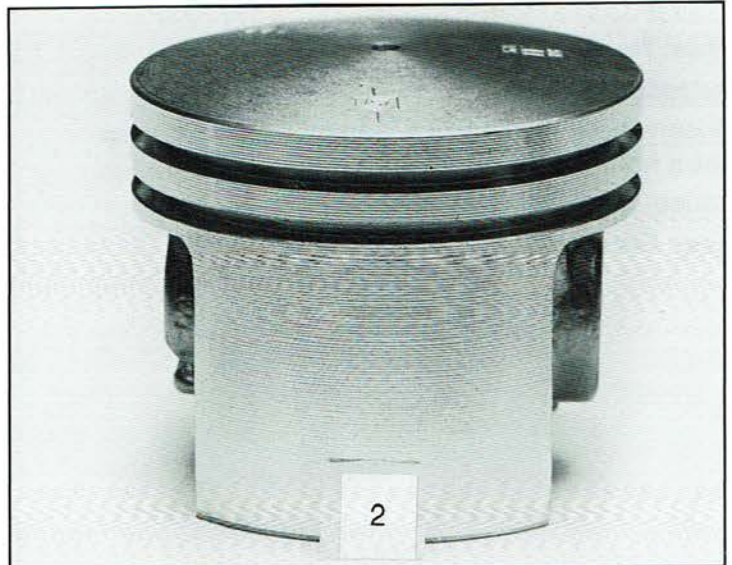
Photo No. 2

Subject: **NEW PISTON**

Observation: Exhaust side – note machine marks, use for reference.

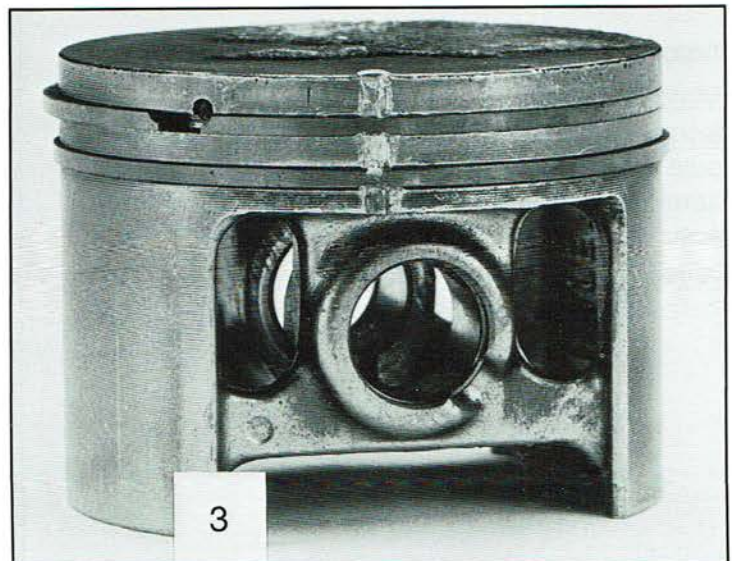
Photo No. 3

Subject: **TRANSFER PORT OF PISTON**

Observation: Piston ported engine, deep score from top edge to piston pin boss.

Cause: Lower con rod bearing and/or cage damaged. RPM's above recommended top end. Leads to excessive load on the components, causing lubrication breakdown.

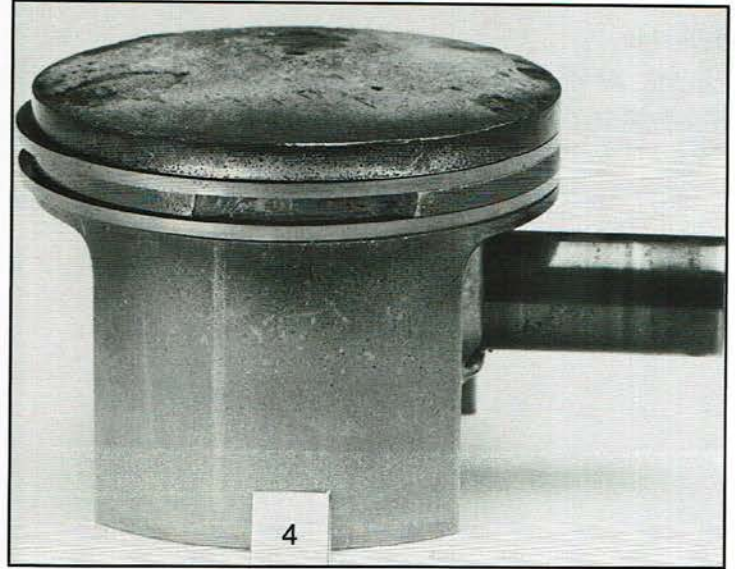
Photo No. 4

Subject: **EXHAUST SIDE OF PISTON**

Observation: Material between ring grooves is broken.

Cause: Over-revving of the engine for extended periods of time can cause ring flutter and extreme heat, which will weaken the piston along with extreme shock from detonation.

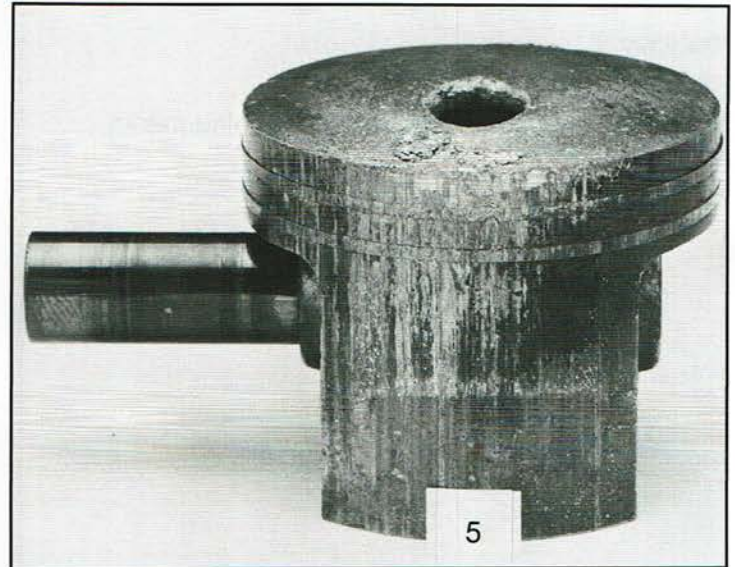
Photo No. 5

Subject: **PISTON**

Observation: Piston has a lean seizure. Piston top has a hole as if burned by a torch.

Cause: Severe lean seizure.

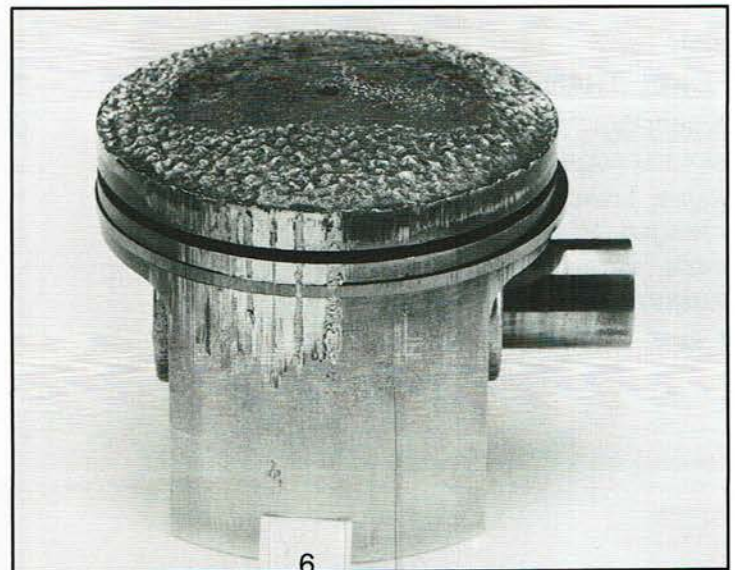
Photo No. 6

Subject: **PISTON**

Observation: Indentations on the piston dome could be perceived as detonation marks. Examination of the cylinder photo No. 39 shows debris was caught in combustion chamber.

Cause: Foreign object has gone through engine. Sharp edges have lead to pre-ignition and seizure.

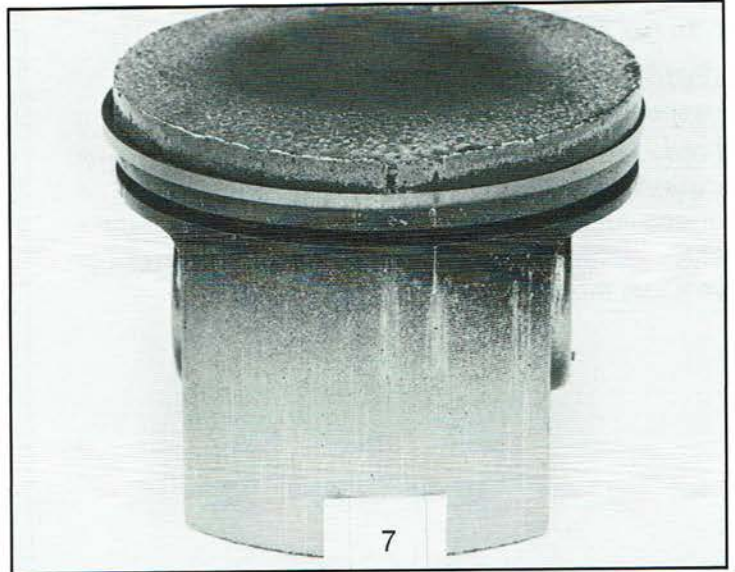
Photo No. 7

Subject: **EXHAUST PISTON SKIRT AND DOME**

Observation: Very fine vertical scratches, may also be on intake, evidence of blow-by on piston sides. Possible detonation marks on piston dome.

Cause: Main bearings may be breaking up and particles getting caught between piston and cylinder.

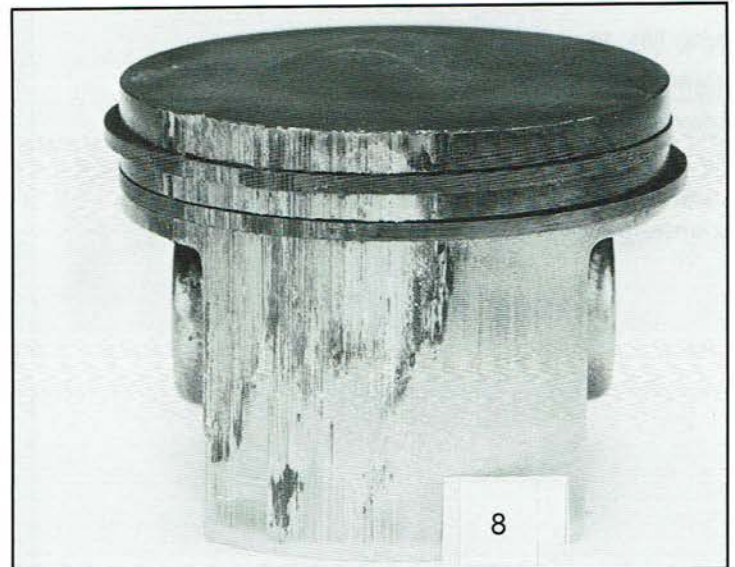
Photo No. 8

Subject: **EXHAUST SIDE OF PISTON**

Observation: PTO half of exhaust side is scored, with possible seized condition. Score marks run from top edge to bottom edge of piston. Note dark dis-coloration around score.

Cause: This is a lean seizure and may have seized more than once. See photo 9, 10, 11.

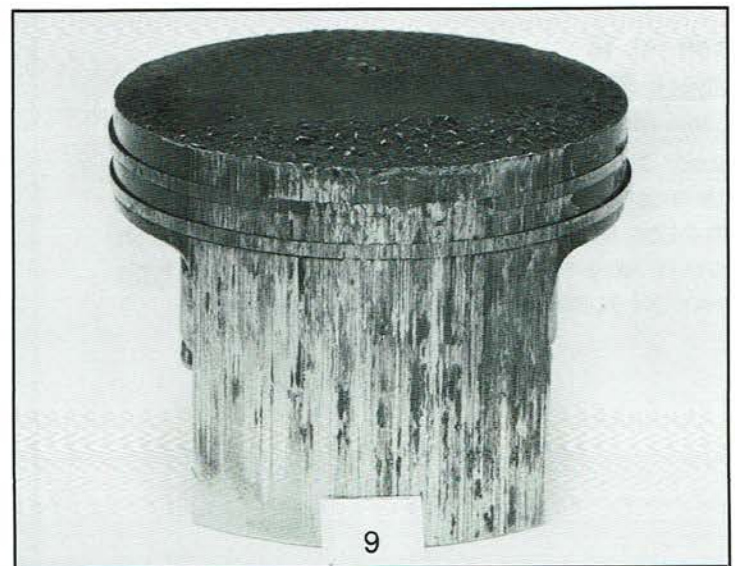
Photo No. 9

Subject: **PISTON**

Observation: Lean seizure.

Cause: Severe detonation.

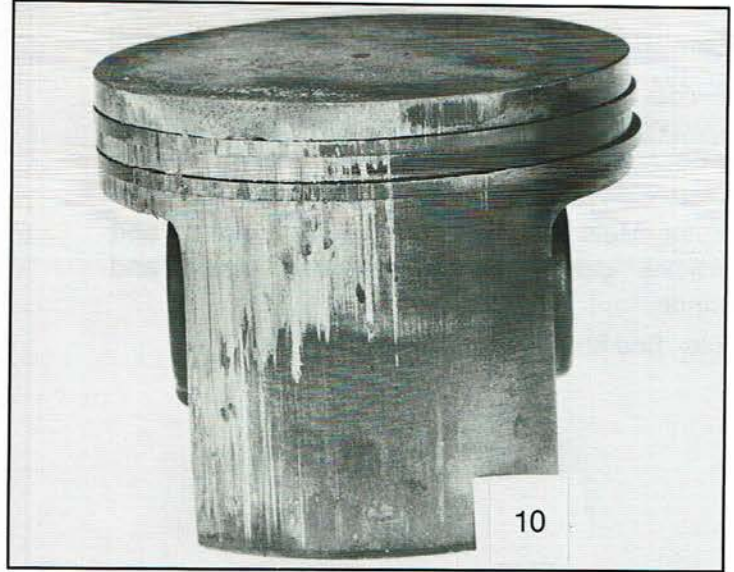
Photo No. 10

Subject: **PISTON**

Observation: Lean seizure.

Cause: Among the possibilities are wrong carburetor settings, stiff carburetor diaphragms, clogged fuel filters, stale gas, alcohol in fuel, air leaks, incorrect ignition timing, part throttle operation, modified mufflers. Note photo 11.

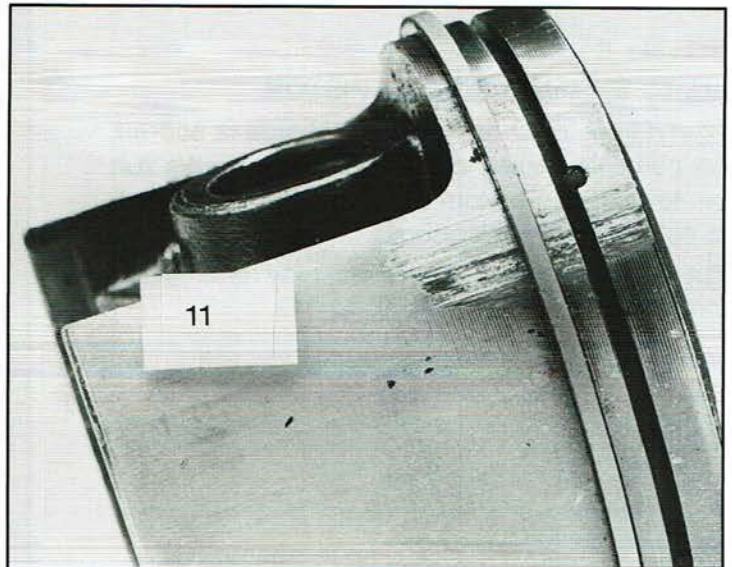
Photo No. 11

Subject: **PISTON**

Observation: Lean seizure.

Cause: This seizure is opposite of the heavy exhaust score and was crowded or pushed by the expanding exhaust side of the piston.

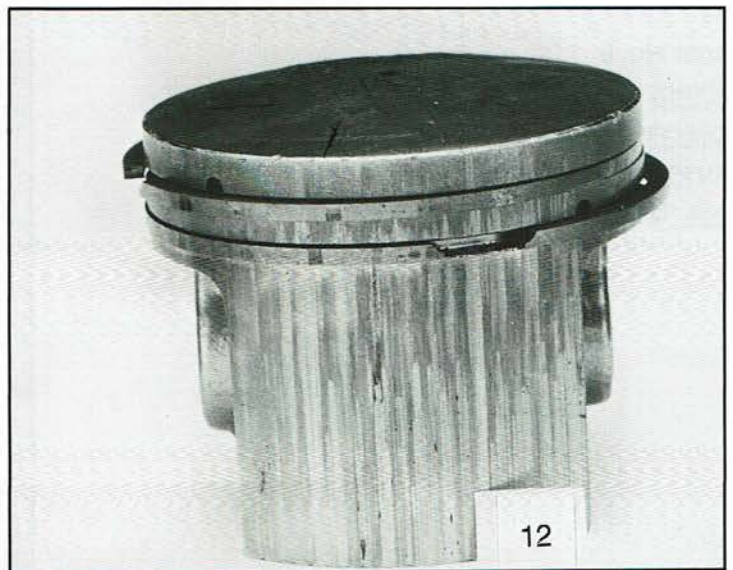
Photo No. 12

Subject: **PISTON INTAKE**

Observation: Piston is scored from the rings down.

Cause: This type of score has two different causes. One is called a snow or water score. The lubricant has been washed of the piston skirt. Occurs in snow or very humid conditions. The second type is alcohol or either score. Effect is the same.

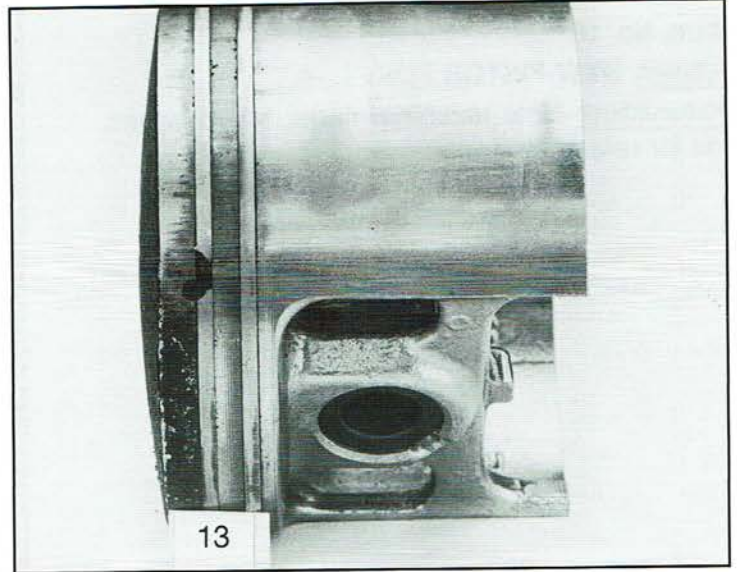
Photo No. 13

**Subject: PISTON INTAKE SKIRT**

**Observation:** Deposits on the piston dome, burnished piston skirt, build up of carbon-like deposits in the ring landings. Rings show beginning of clipping condition. Intake skirt is highly polished.

**Cause:** Combination of ingested fine dirt, fuel and oil mix build up in the ring grooves inhibiting the ring movement.

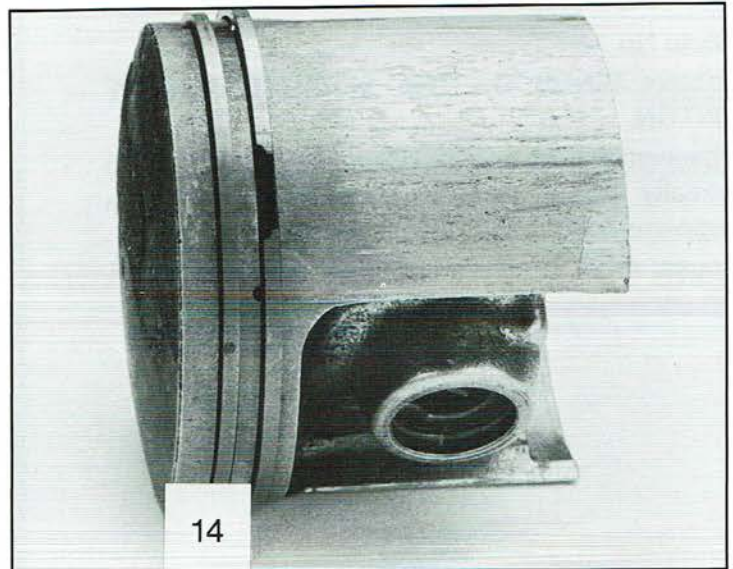
Photo No. 14

**Subject: INTAKE SKIRT OF PISTON**

**Observation:** Skirt has been ground and scored.

**Cause:** Dirt and grit ingested into the engine. Note photo 41 for the cylinder damage.

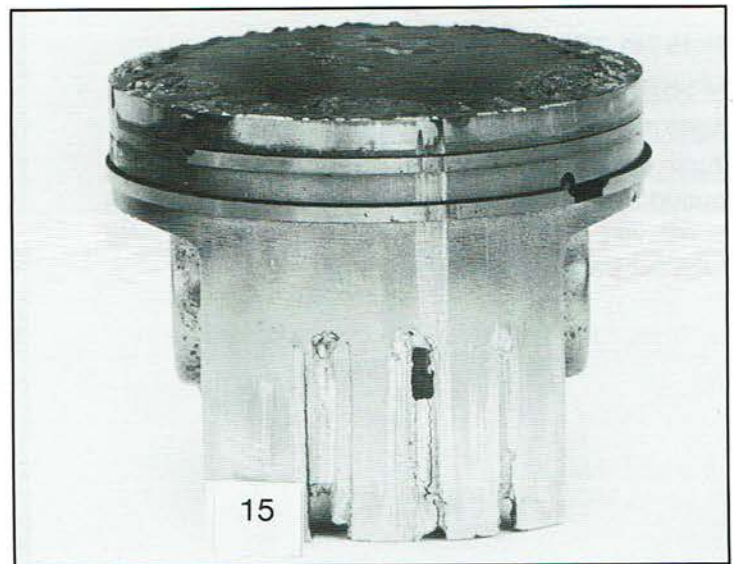
Photo No. 15

**Subject: INTAKE SIDE OF PISTON**

**Observation:** Deep scores, broken skirt, marks in the dome of piston.

**Cause:** Foreign debris caught between intake port and the piston skirt.

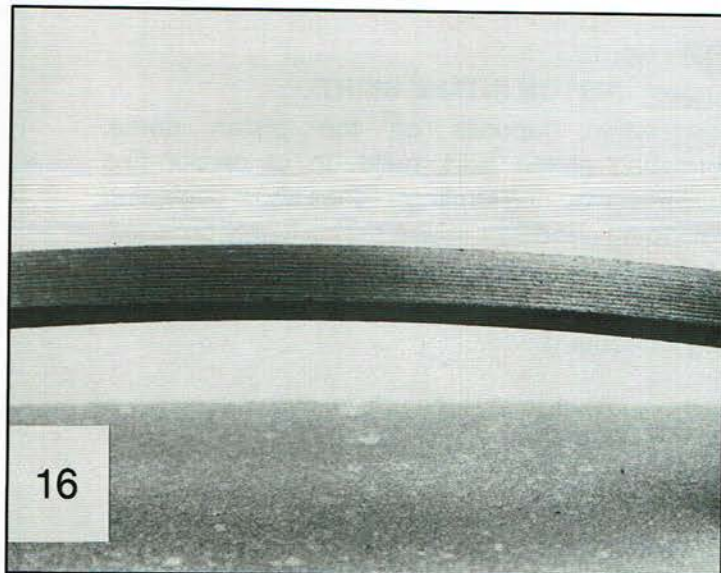
Photo No. 16

Subject: **NEW PISTON RING**

Observation: Note machine marks, sharp edges.  
Use for reference.

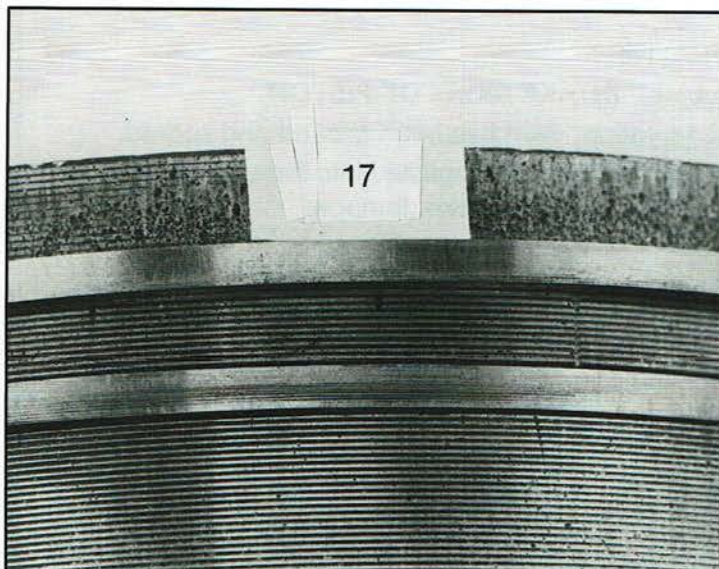
Photo No. 17

Subject: **RINGS ON THE EXHAUST SIDE OF PISTON**

Observation: Top ring almost broken in, bottom ring partially broken in, area above top ring has a peppered look.

Cause: Ring wear is normal, top ring seats first, dirt particles can cause a peppered effect.

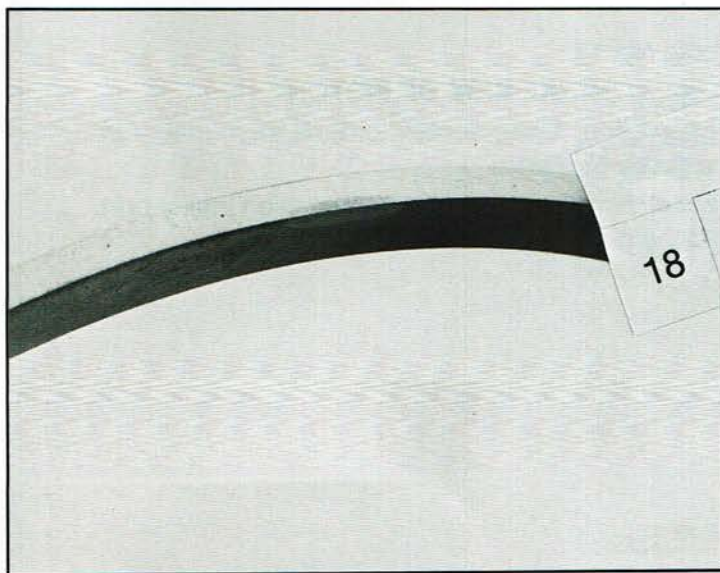
Photo No. 18

Subject: **PISTON RING**

Observation: Sharp edge on the ring is burnished.

Cause: This is the first sign of ring clipping. This is caused by over revving the engine. Because of the excessive piston speed the rings do not have time to retract into their grooves.

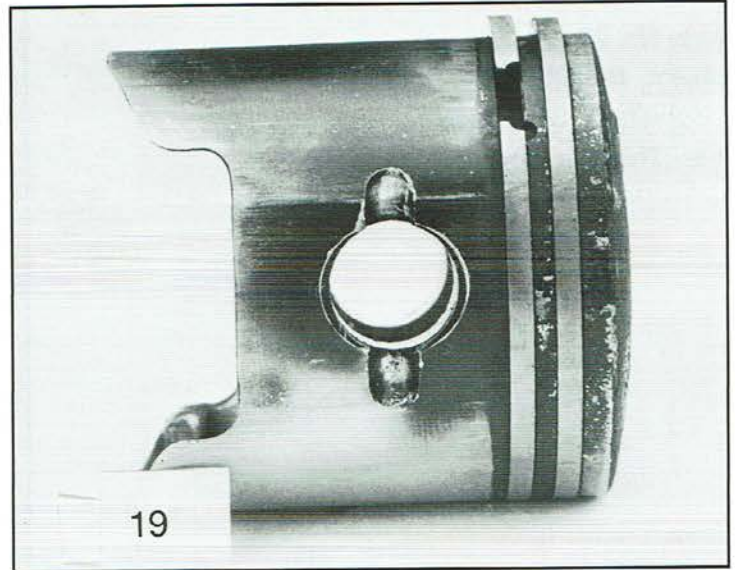
Photo No. 19

**Subject: PISTON**

**Observation:** Heavy build up on top and sides of piston, partial ring sticking.

**Cause:** Improper fuel/oil mix or ratio. These symptoms are also related to improper RPM operations. Example half throttle running.

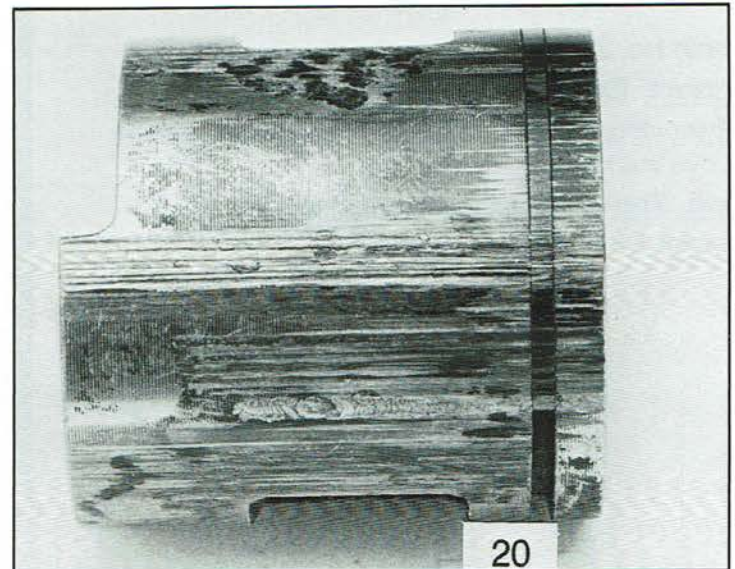
Photo No. 20

**Subject: PISTON**

**Observation:** Piston scored over most of surface from the top to the bottom, dark discoloration in and around the score.

**Note:** This piston is from a long stroke, reed plate, induction type engine.

**Cause:** This is lean seizure.

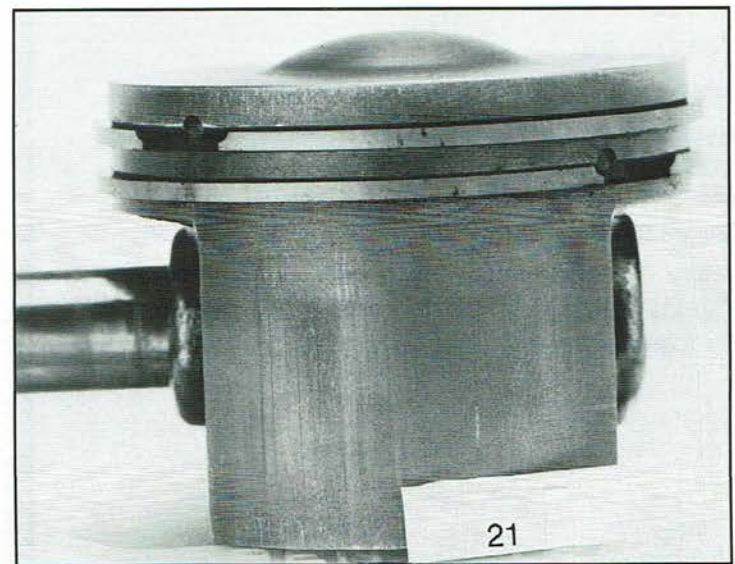
Photo No. 21

**Subject: INTAKE SKIRT OF THE PISTON**

**Observation:** Intake skirt has tiny scratches and a sandblasted look. Some of the machine marks are still visible. Piston in service only a short period of time.

**Cause:** Dirt ingested into the engine. Piston is from an actual test engine.

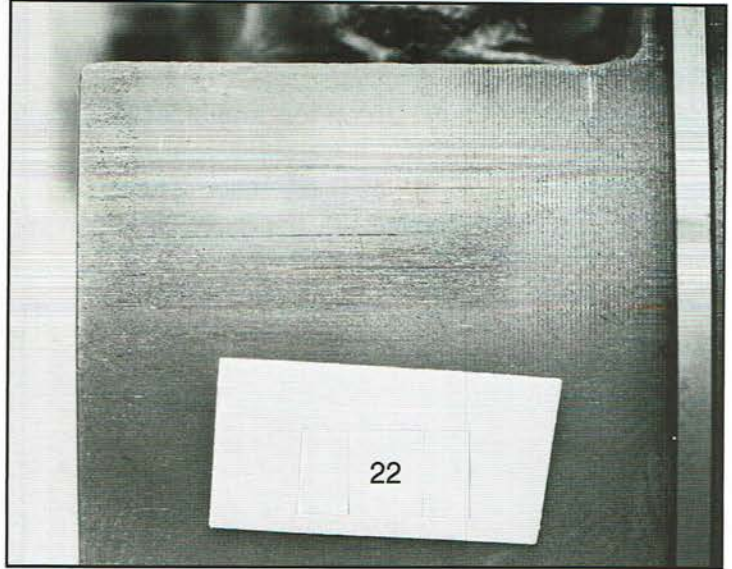
Photo No. 22

**Subject: INTAKE SIDE OF THE PISTON**

**Observation:** See photo No. 21.

**Note:** This is a close up of photo 21.

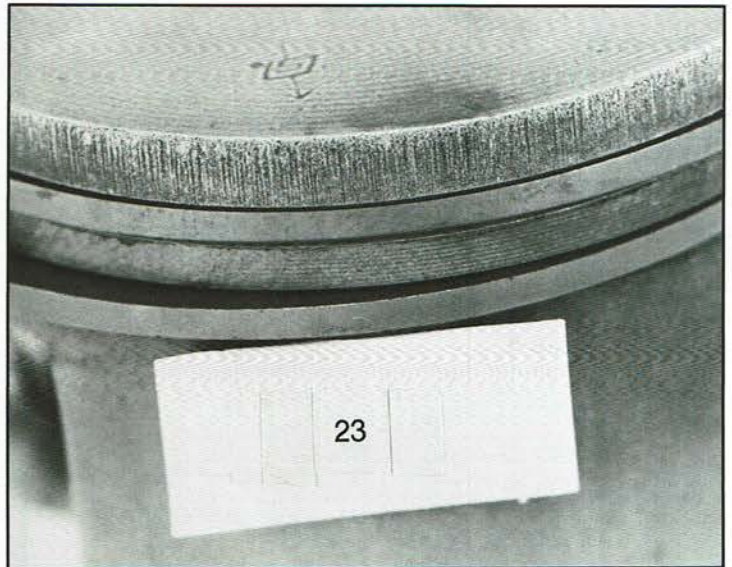
Photo No. 23

**Subject: EXHAUST SIDE OF THE PISTON**

**Observation:** Pitted and scratched piston surface above the rings.

**Note:** The wear on the piston rings.

**Cause:** Dirt in the exhaust flow.

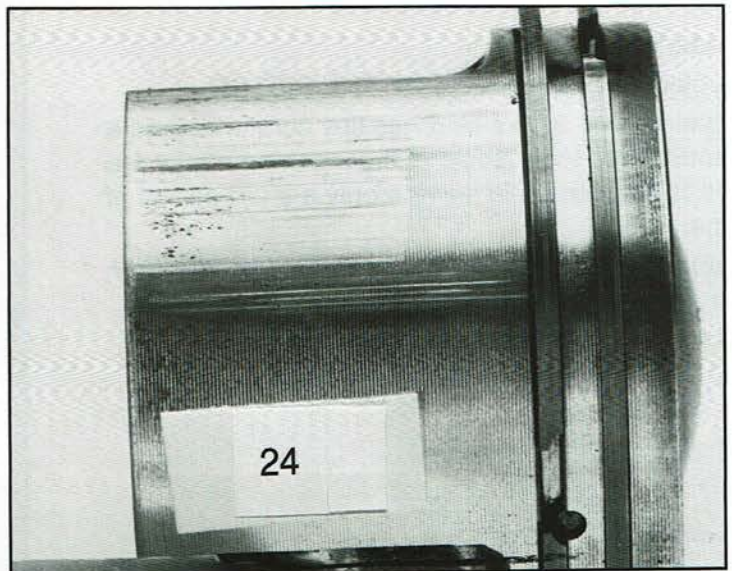
Photo No. 24

**Subject: INTAKE SIDE OF THE PISTON**

**Observation:** Score marks are primarily below the rings to the bottom of the skirt. On the flywheel side of the skirt they are found across the entire face of the piston.

**Cause:** Snow/water score. A pre-heater kit would prevent icing conditions. Wet (water score) air filter. Dry filter before use. Alcohol or ether in gas.

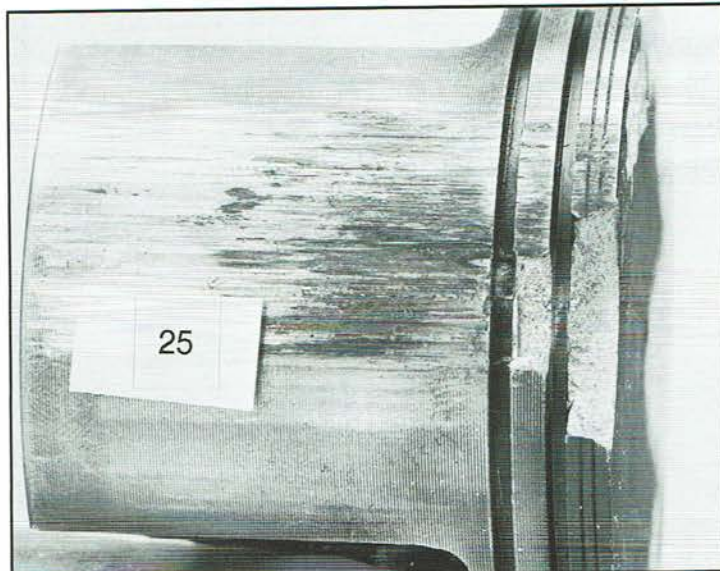
Photo No. 25

**Subject:** EXHAUST SIDE OF PISTON

**Observation:** Piston is broken from the upper edge down to bottom ring. This is different from photo 4.

**Cause:** Saw was run lean, rings got too tight in grooves and clipped the port. Rings have been caught on bottom edge of exhaust port, broken on the down stroke. Check engine for over revving.

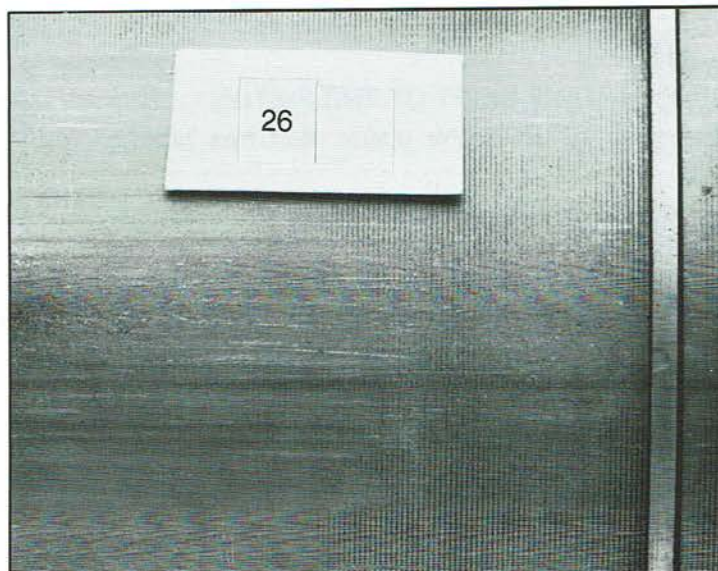
Photo No. 26

**Subject:** INTAKE SKIRT OF THE PISTON

**Observation:** Piston surface worn, various patterns and shades.

**Cause:** Dirt ingested into the engine. Different types of dirt will cause different score patterns. Dirty, worn or wrong application air filter will change scoring patterns on piston.

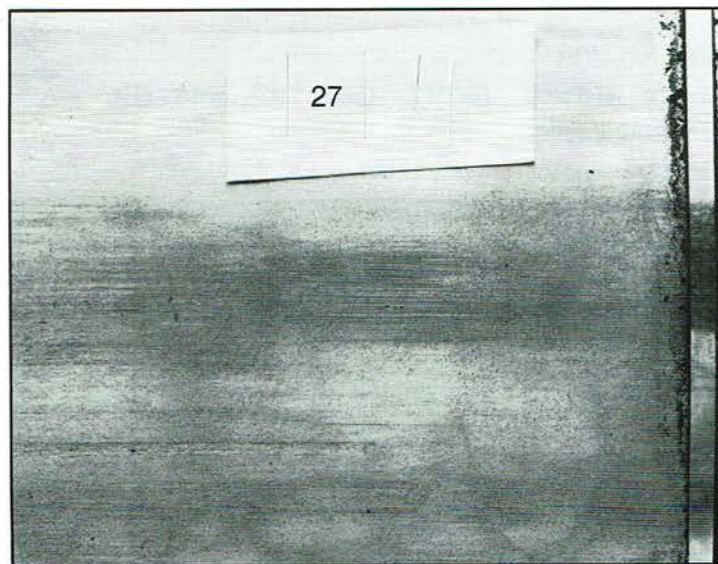
Photo No. 27

**Subject:** INTAKE SKIRT OF THE PISTON

**Observation:** Same as photo No. 26.

**Cause:** Same as photo No. 26.

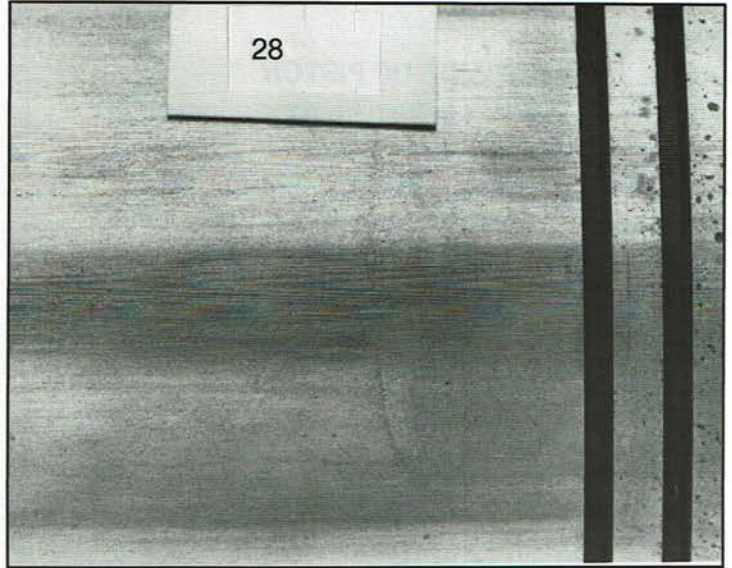
Photo No. 28

**Subject:** INTAKE SKIRT OF THE PISTON

**Observation:** Same as photo No. 26.

**Cause:** Same as No. 26.

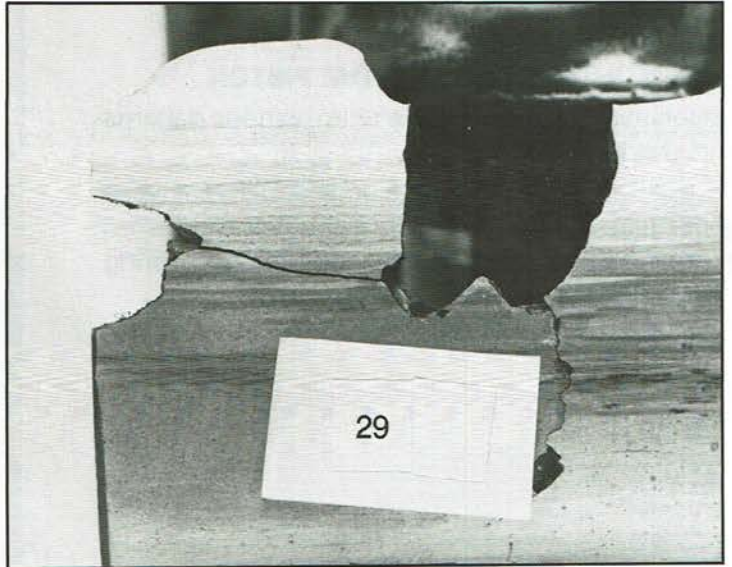
Photo No. 29

**Subject:** INTAKE SKIRT OF THE PISTON

**Observation:** Part of the piston skirt has broken away.

**Cause:** The intake skirt has been worn thin by abrasive dirt ingested into the engine. When the tolerances got too big the piston began to slap itself against the cylinder wall until it broke up.

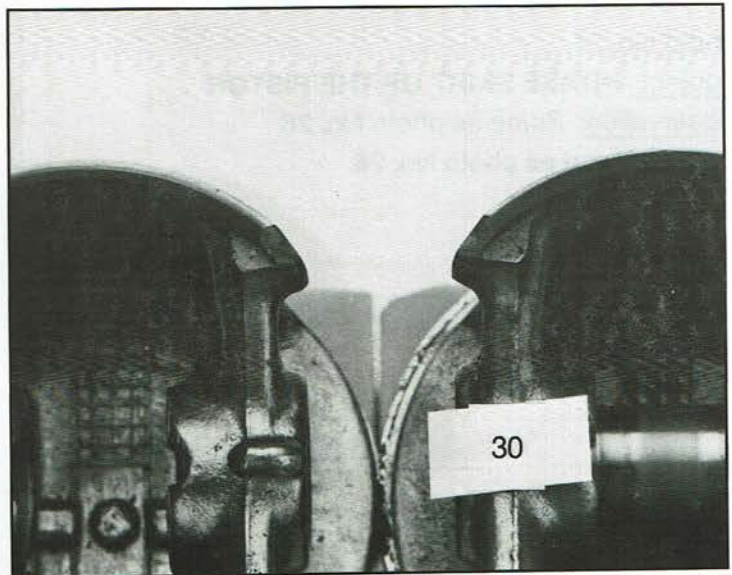
Photo No. 30

**Subject:** INTAKE SKIRT OF THE PISTON. BOTTOM VIEW.

**Observation:** The intake skirts are at the top of the picture. The piston skirt on the right is much thinner than the skirt on the left.

**Cause:** Dirt ingested into the engine. Dirt is an abrasive and wears down the surfaces it comes in contact with.

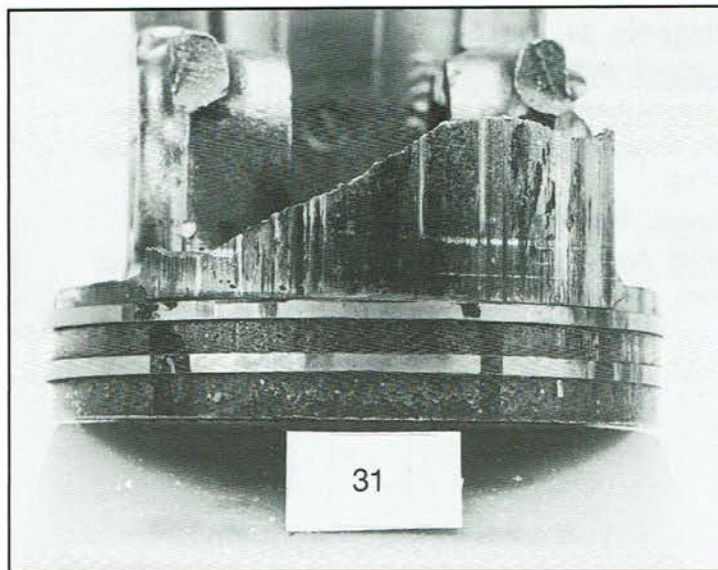
Photo No. 31

Subject: **EXHAUST SIDE OF THE PISTON**

Observation: Skirt is broken and scored.

Cause: Carbon build up in exhaust port breaking off and lodging in between the piston and cylinder walls.

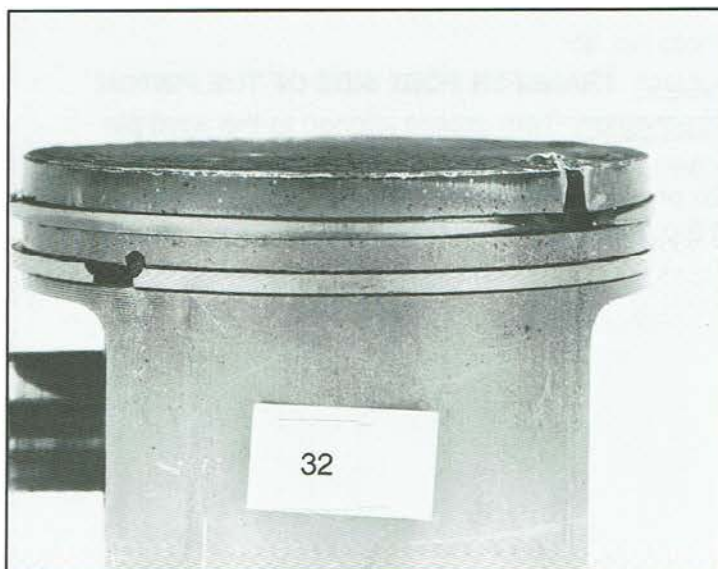
Photo No. 32

Subject: **PISTON LOCATING PIN FOR RINGS**

Observation: Top locating pin has been hammered through the top of the piston.

Cause: Over revving the engine. Ring was jammed into the ring groove when the ring passes the port. The ring end hammers on the locating pin.

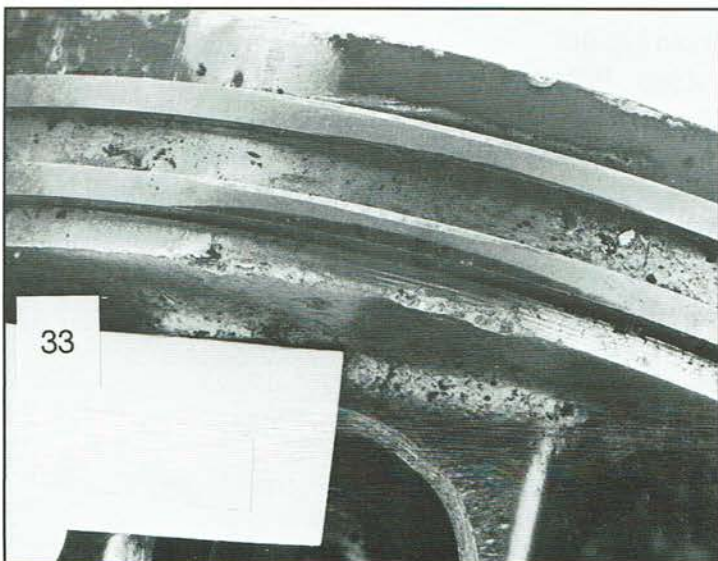
Photo No. 33

Subject: **PISTON RINGS**

Observation: Edges of the rings are worn excessively. See photos 16, 18.

Cause: Over revving of the engine. See photos 16, 18.

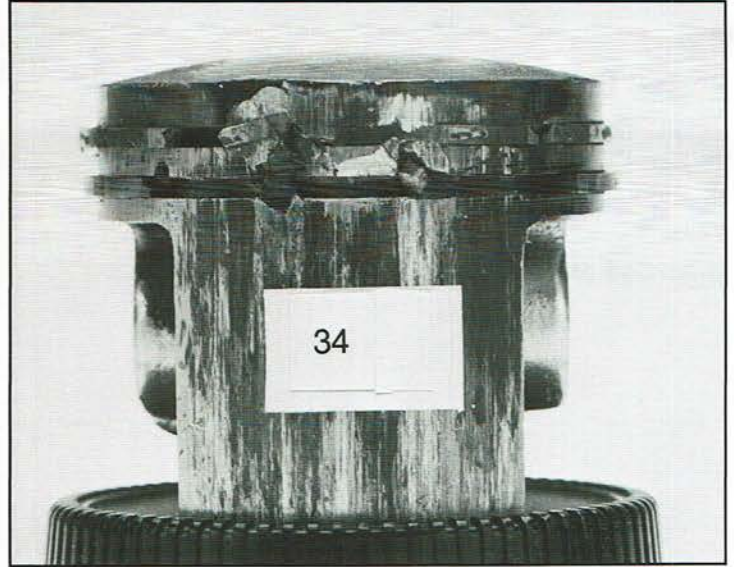
Photo No. 34

Subject: **PISTON**

Observation: Rings and ring landings are broken up. Similar to photo No. 25 but locating pins are intact.

Cause: Piston was installed backwards.

Note: Arrow on piston top always points to exhaust port.

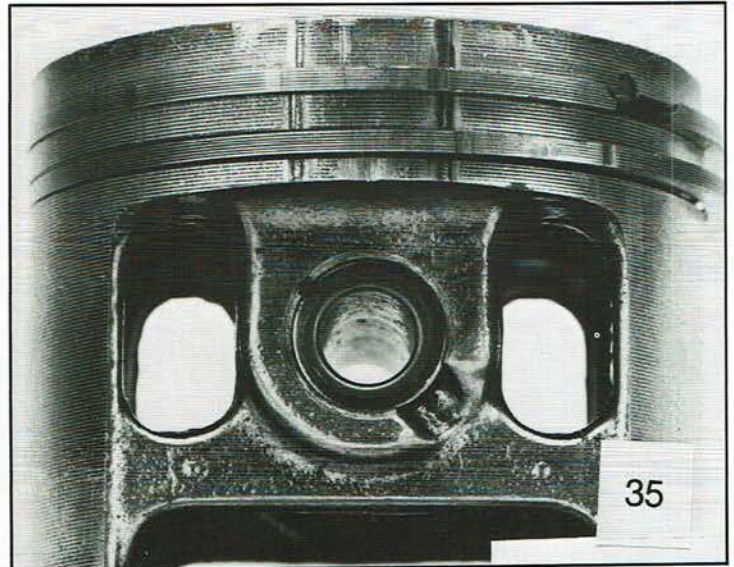
Photo No. 35

Subject: **TRANSFER PORT SIDE OF THE PISTON**

Observation: Twin scores aligned to the wrist pin.

Cause: Wrist pin keeper has come out of piston pin or was not installed. Related damage may be at the bridge of the transfer port.

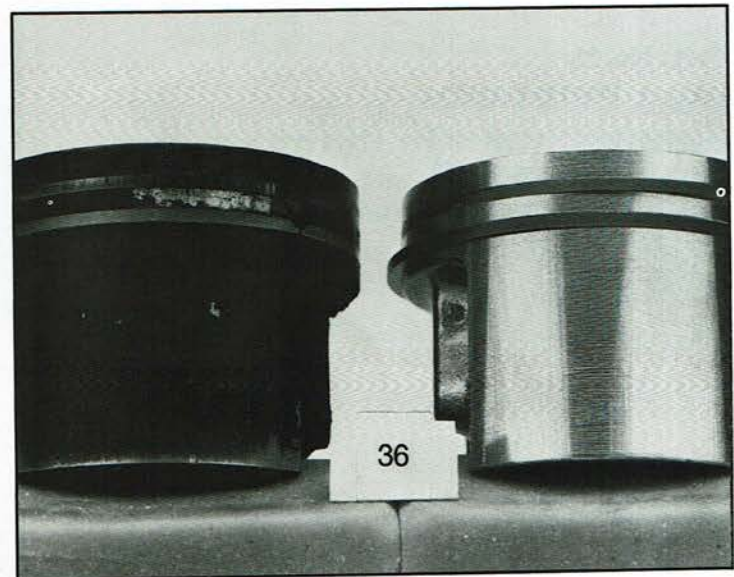
Photo No. 36

Subject: **PISTON**

Observation: Piston on the right is new, piston on the left is coated with a sticky, wax-like varnish.

Cause: Something has been added to the fuel. Possibly bar oil was used as engine oil, or some other unburnable substance.

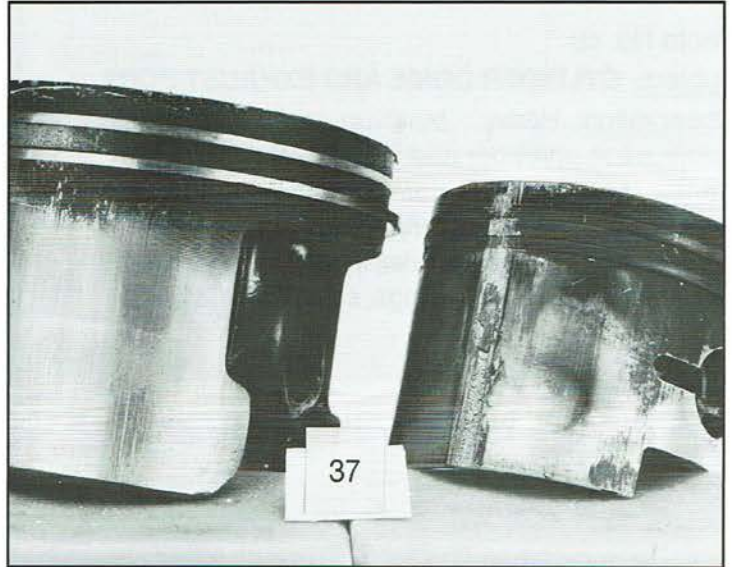
Photo No. 37

**Subject:** PISTON RING AND PISTON SKIRT

**Observation:** Varnish and gum build up in and around the ring area.

**Cause:** Improper fuel/mixture or incorrect mixing ratio.

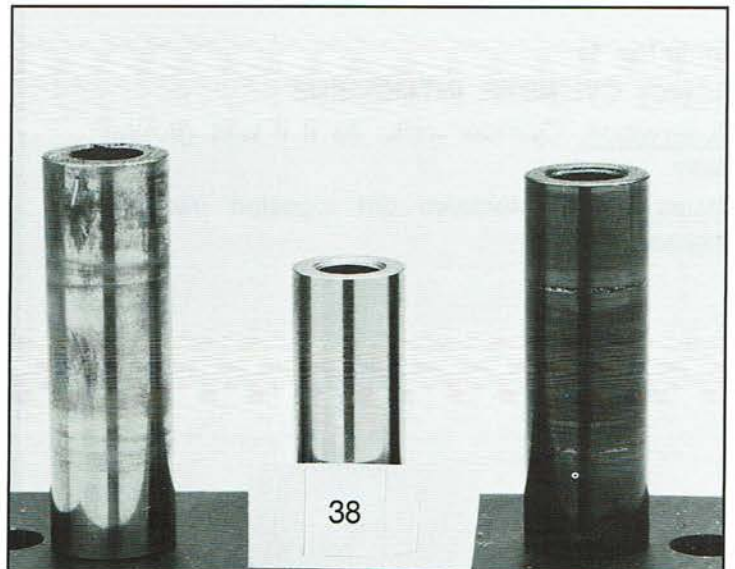
Photo No. 38

**Subject:** PISTON PINS

**Observation:** Pin on the right is discolored by extreme heat. Pin in the middle is new. The pin on the left is worn.

**Cause:** Pin on the right, the engine has been over revving and this has caused the lubricating oil to breakdown. Pin on the left is worn from abrasive dirt ingested into the engine.

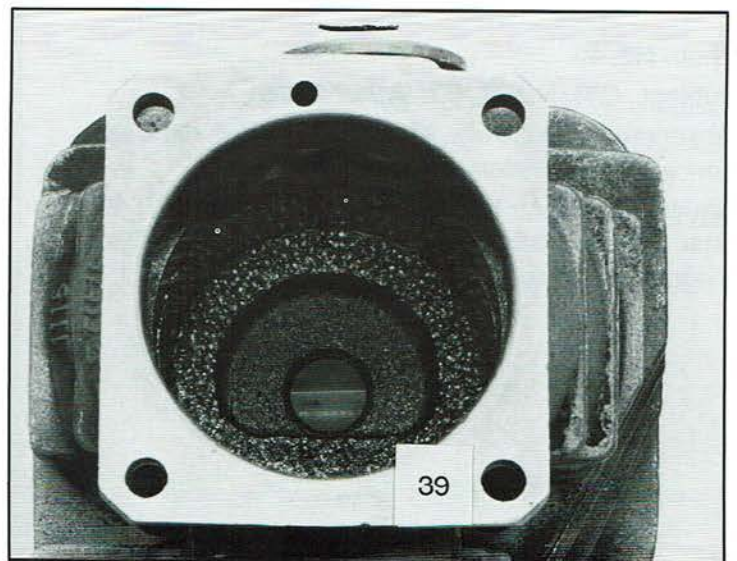
Photo No. 39

**Subject:** CYLINDER

**Observation:** Indentations on the top of the combustion area.

**Cause:** Foreign debris has gone through the engine. See photo No. 6.

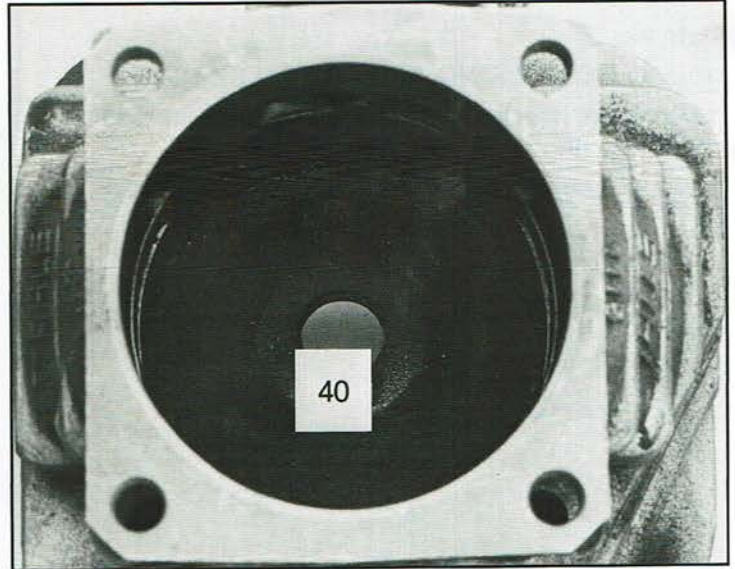
Photo No. 40

**Subject:** CYLINDER DOME AND EXHAUST PORT

**Observation:** Heavy build-up of carbon in combustion chamber and in exhaust ports.

**Cause:** Any one or a combination of incomplete burn of fuel/oil mix, incorrect engine mix oil, choke malfunction, clogged air filter, incorrect fuel/oil ratio improper carburetor settings, see photos 31, 42.

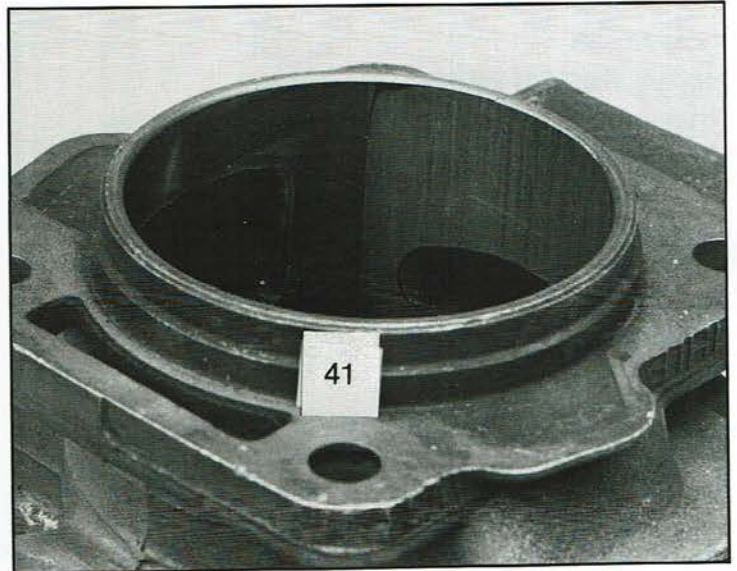
Photo No. 41

**Subject:** CYLINDER, INTAKE SIDE

**Observation:** Cylinder looks as if it was ground away.

**Cause:** Severe abrasive dirt ingested into the engine.

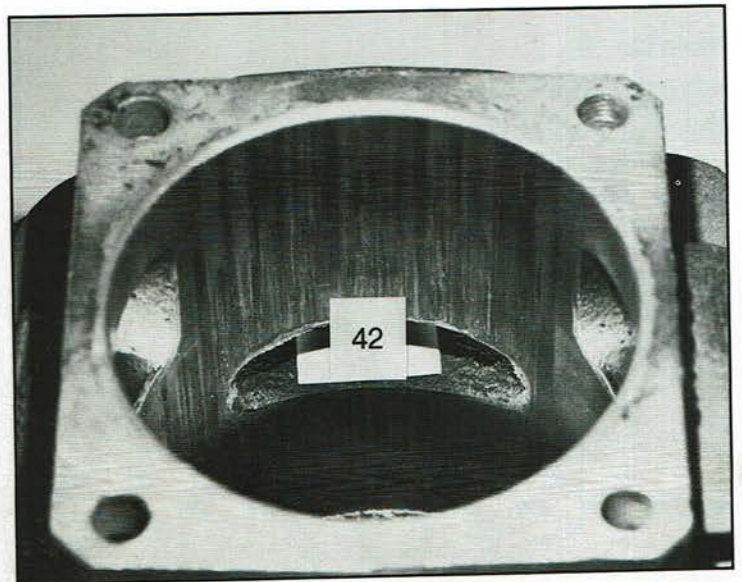
Photo No. 42

**Subject:** CYLINDER, EXHAUST SIDE

**Observation:** Build-up of carbon in the exhaust port and combustion chamber.

**Cause:** Incorrect fuel/oil mix, incorrect fuel/oil ratio, incorrect carburetor settings, clogged air filter, clogged fire screen.

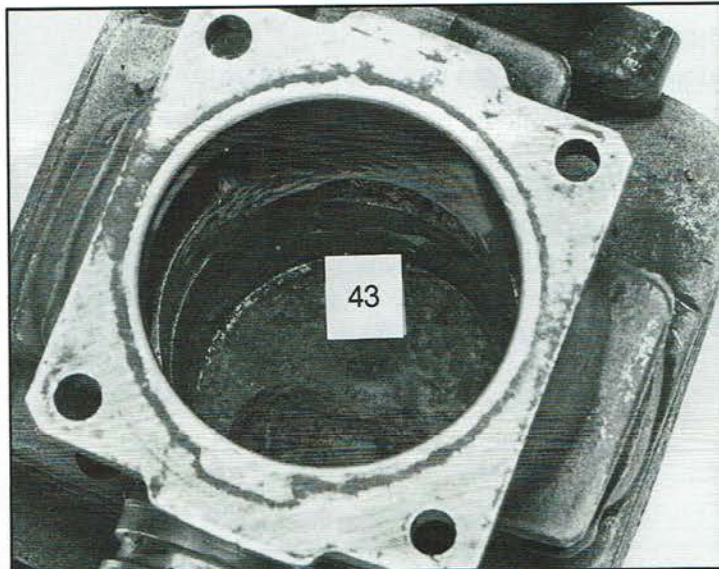
Photo No. 43

Subject: **CYLINDER**

Observation: Chrome in cylinder is flaking off and under layer of whitish colored powder.

Cause: Moisture in the form of water has caused this damage. See also photo No. 67.

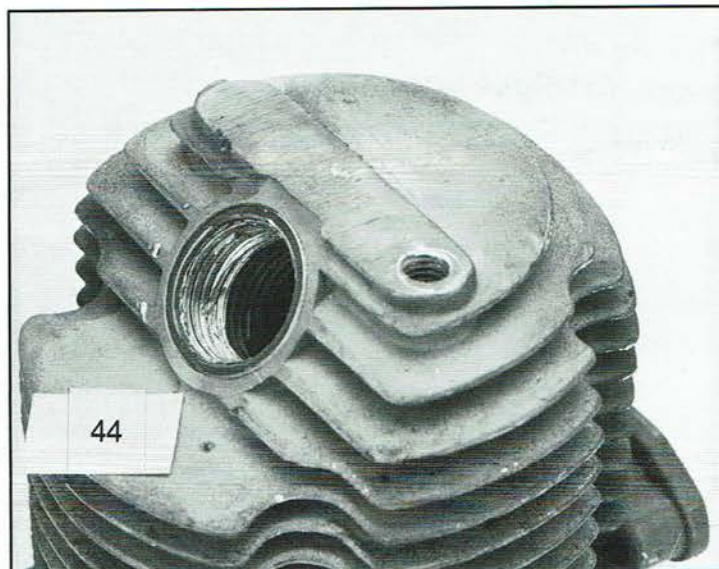
Photo No. 44

Subject: **NEW CYLINDER - SPARK PLUG THREADS**

Observation: Threads are stripped the length of the plug.

Cause: Plug was installed incorrectly with an air wrench.

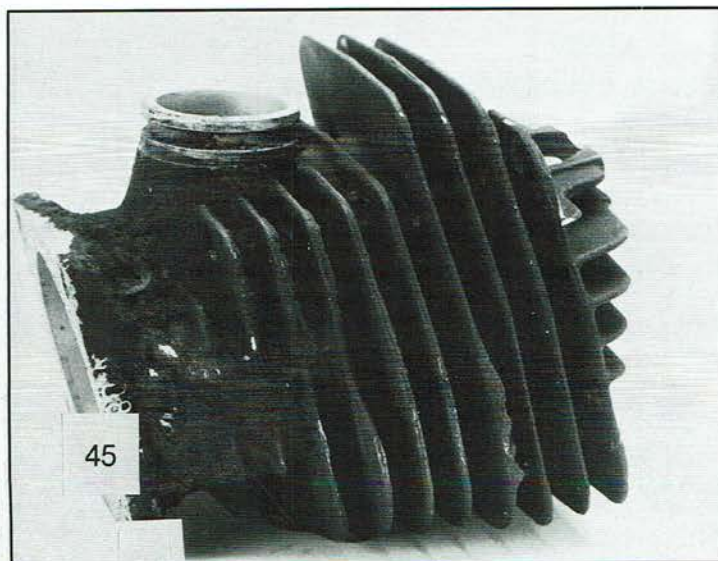
Photo No. 45

Subject: **CYLINDER COOLING FINS**

Observation: Cooling fins are clogged with a build-up of tree sap and sawdust. Saw is developing heat related problems.

Cause: Poor operator maintenance, saw should be checked and cleaned if necessary once a week.

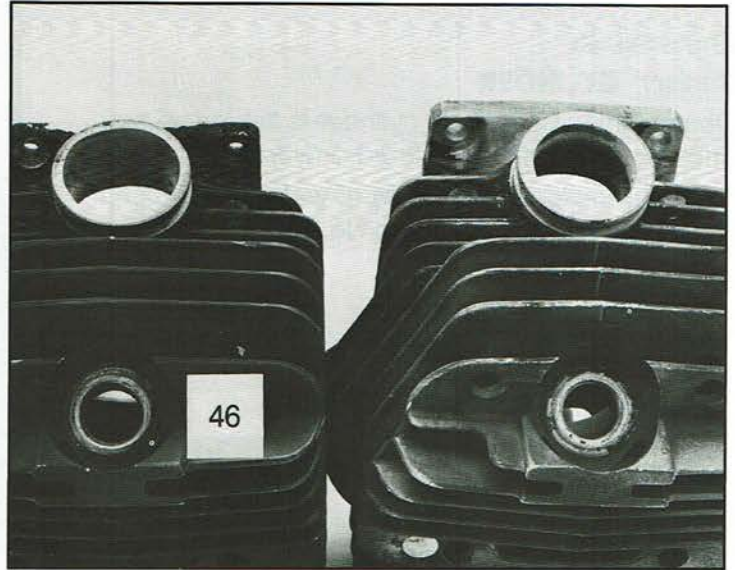
Photo No. 46

**Subject:** CYLINDERS INTAKE PORT VIEW

**Observation:** Cylinder on the left has a larger intake port.

**Cause:** Cylinders are the same, the one on the left has been modified by enlarging the intake port. This has caused an overloading of the engine and shortened the life of this engine. This type of modification voids the engine warranty.

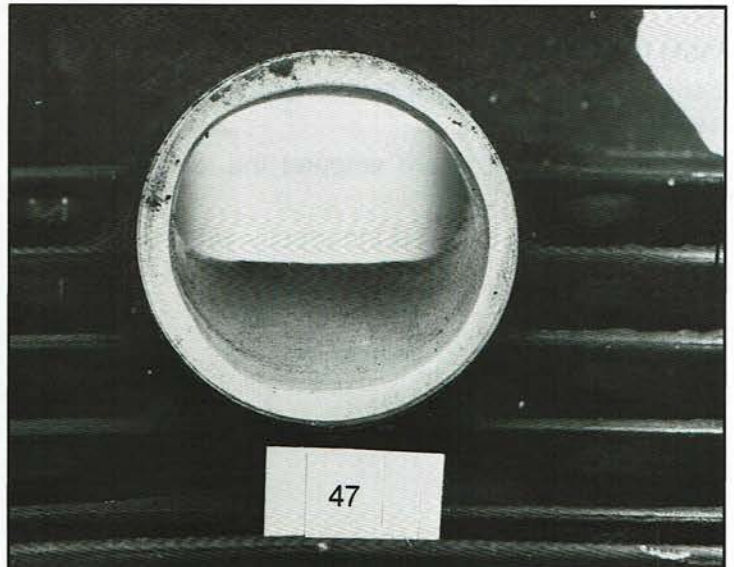
Photo No. 47

**Subject:** CYLINDER INTAKE PORT

**Observation:** Close-up of modified cylinder in photo No. 46.
