**Engine Failure  
Analysis Manual**

# **STIHL ENGINE FAILURE ANALYSIS MANUAL**

This manual has been designed as an aid to the servicing dealer in diagnosing why an engine has failed. We have attempted to include as many examples as possible, but there are probably some we have missed. Perhaps as these come to our attention we can include them in future editions.

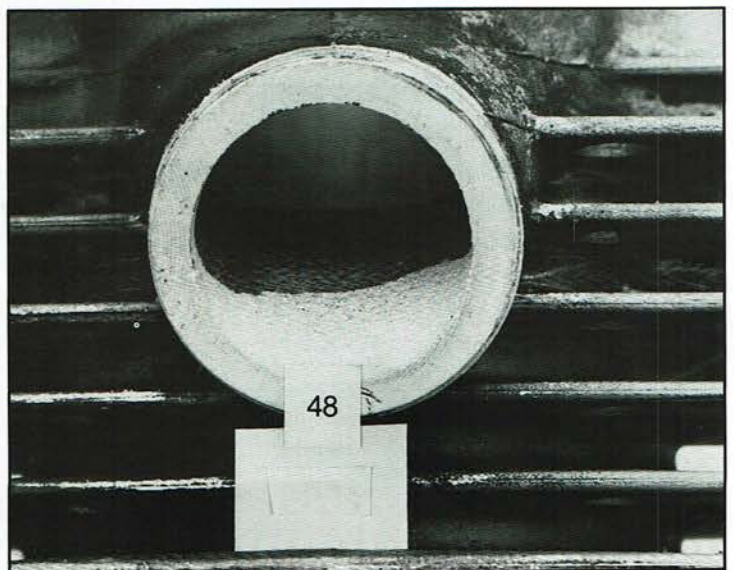
Photo No. 48

**Subject:** CYLINDER INTAKE PORT

**Observation:** Close up of stock cylinder intake port. Compare to photo No. 47.

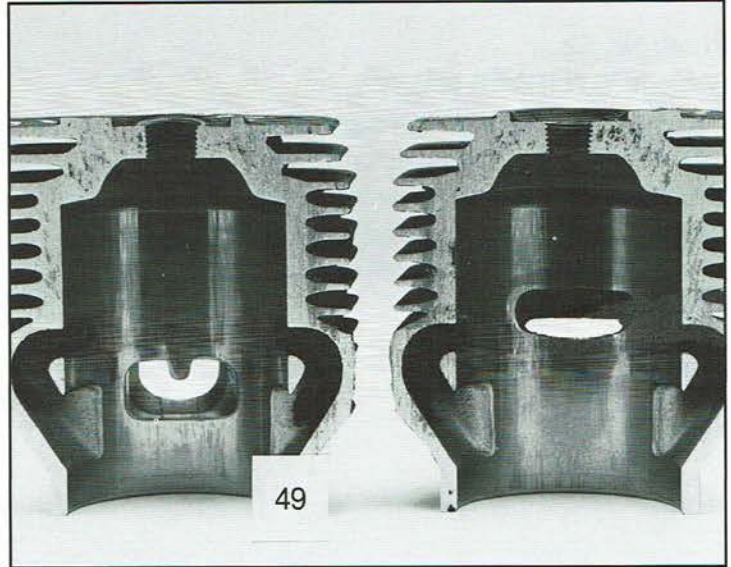
Photo No. 49

Subject: **BISECTED CYLINDER FOR A PISTON PORTED ENGINE**

Observation: Note the dirt build-up in the transfer ports and the dirt and carbon crusting in the combustion chamber.

Cause: Poor maintenance of the air filter and/or fuel/oil mix and fuel/oil ratio.

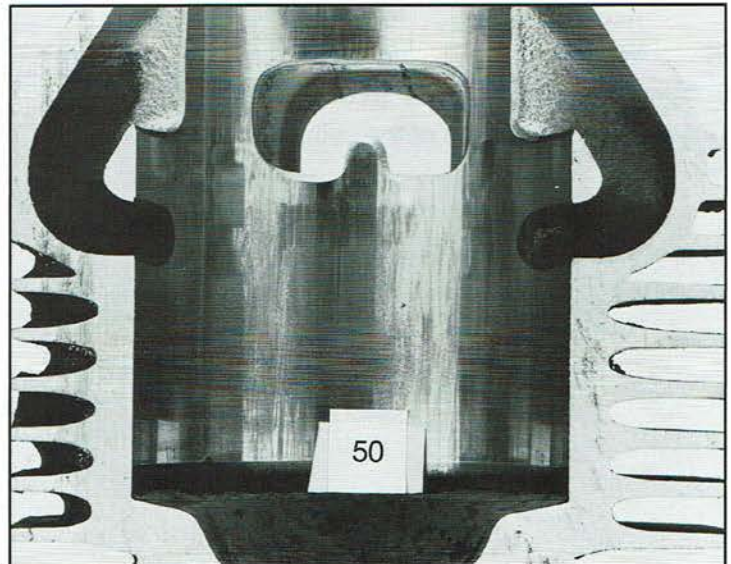
Photo No. 50

Subject: **CYLINDER HALF**

Observation: Close-up of the intake port half of cylinder in photo No. 49. Inverted view.

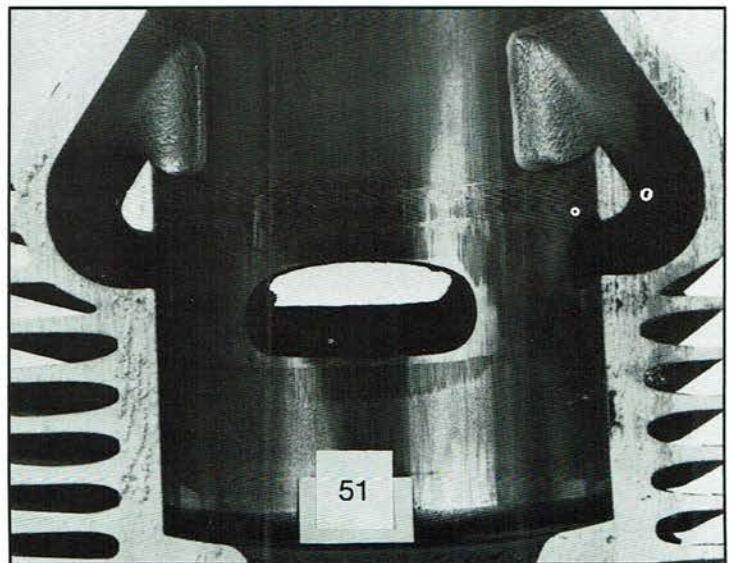
Photo No. 51

Subject: **CYLINDER HALF**

Observation: Close up of the exhaust half of the cylinder in photo No. 49. Inverted view.

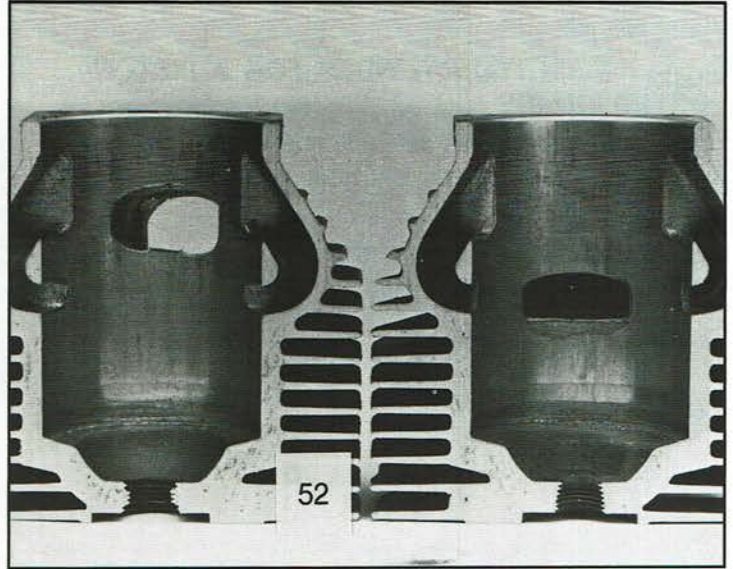
Photo No. 52

**Subject:** CYLINDER HALVES

**Observation:** Cylinder has damage to the cylinder wall in the area of the exhaust port, as well as scratches above and below intake port.

**Cause:** Engine has ingested a lot of abrasive dirt. The piston wore to the point of breaking up in the cylinder.

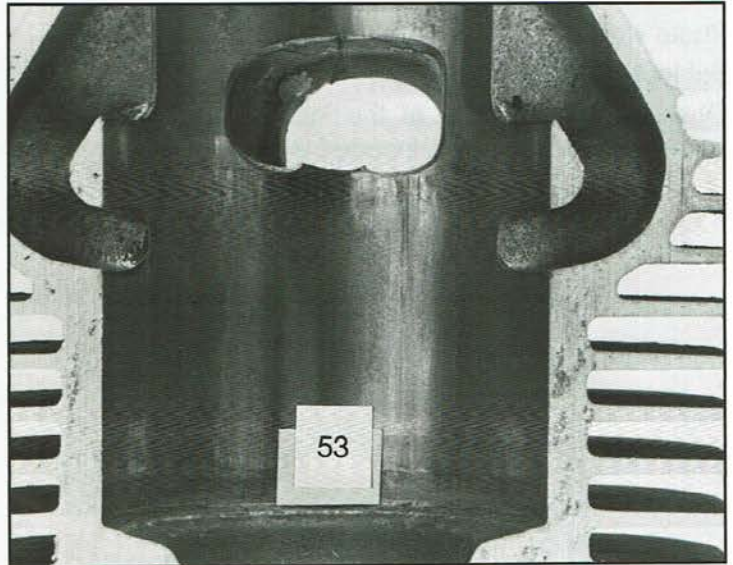
Photo No. 53

**Subject:** CYLINDER HALF INTAKE PORT

**Observation:** Close-up of the cylinder half in photo No. 52.

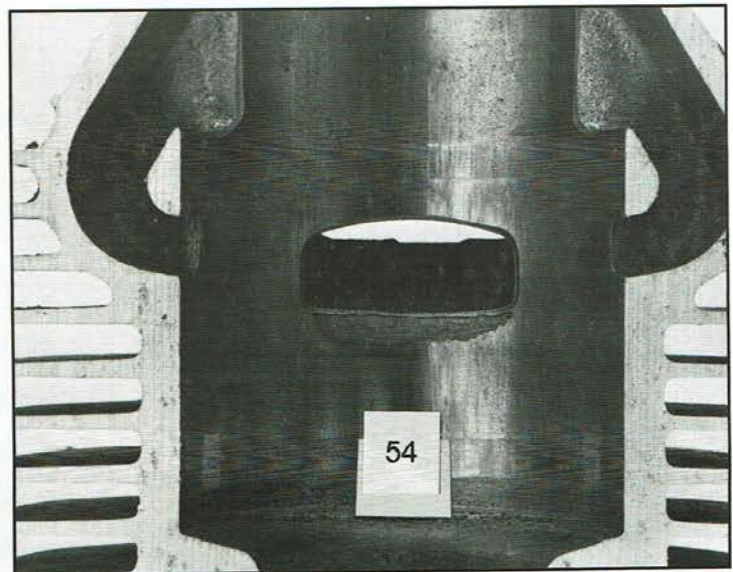
Photo No. 54

**Subject:** CYLINDER HALF EXHAUST PORT

**Observation:** Close up of the cylinder half in photo No. 52.

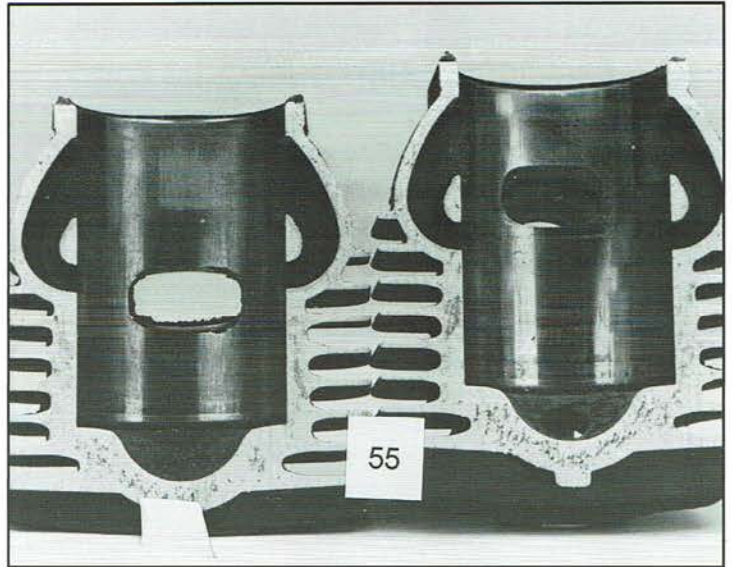
Photo No. 55

Subject: **CYLINDER HALVES**

Observation: Heavy burnishing on the cylinder walls, dirt build-up in the transfer ports and in the combustion chamber.

Cause: Engine has ingested abrasive dirt.

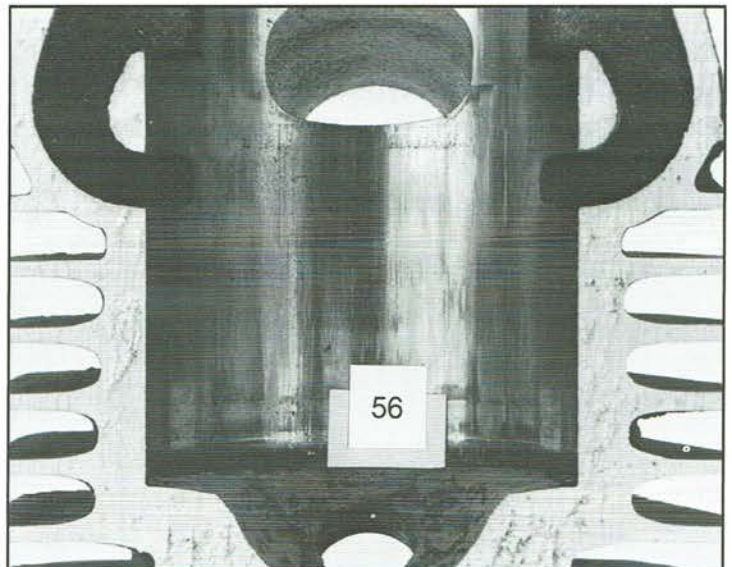
Photo No. 56

Subject: **CYLINDER HALF INTAKE SIDE**

Observation: Heavy burnishing and grinding on the cylinder walls. Build-up of dirt in the transfer ports and combustion chamber. Close-up of photo No. 55.

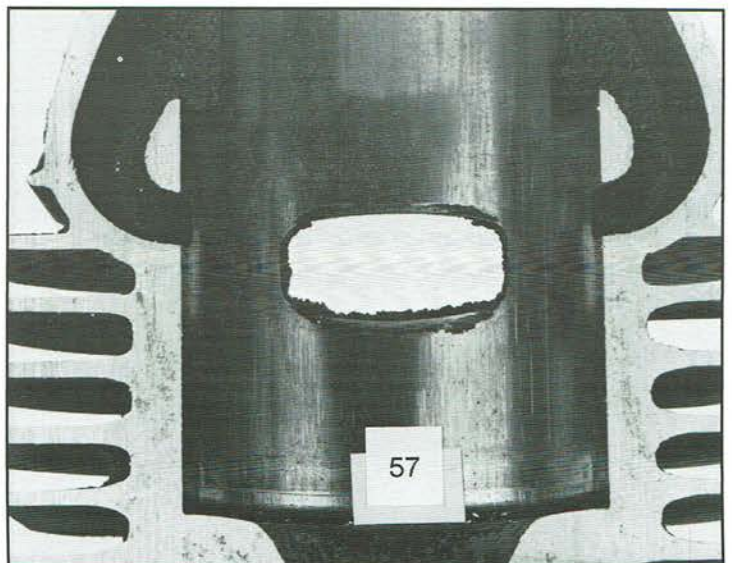
Photo No. 57

Subject: **CYLINDER HALF EXHAUST SIDE**

Observation: Dirt in the transfer ports, pitting and grinding around exhaust port areas and a build-up of dirt in the combustion chamber. Close-up of cylinder in photo No. 55.

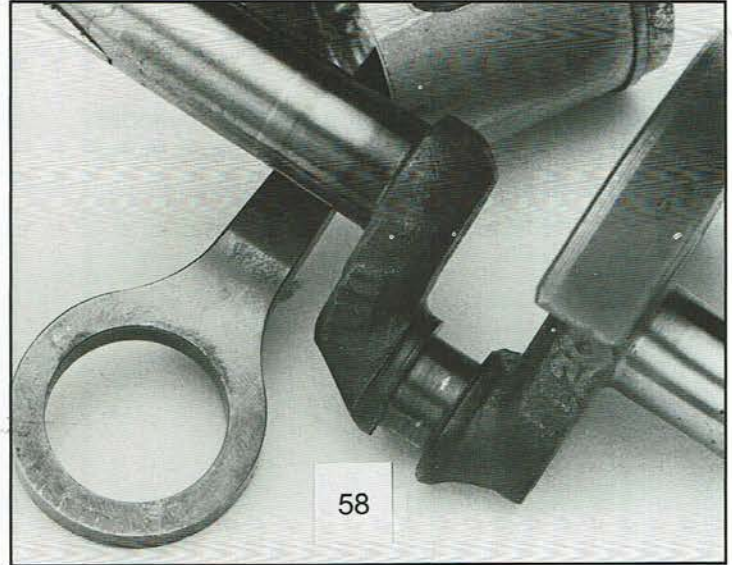
Photo No. 58

Subject: **CRANKSHAFT AND CONNECTING ROD**

Observation: Connecting rod and crankshaft stroke pin both show over heating.

Cause: Over revving of the engine has caused the lubrication to breakdown and the bearings to overheat. Note also that dirt wear on the upper connecting rod bearing will put excessive side load on the connecting rod, leading to overheating and lubrication breakdown.

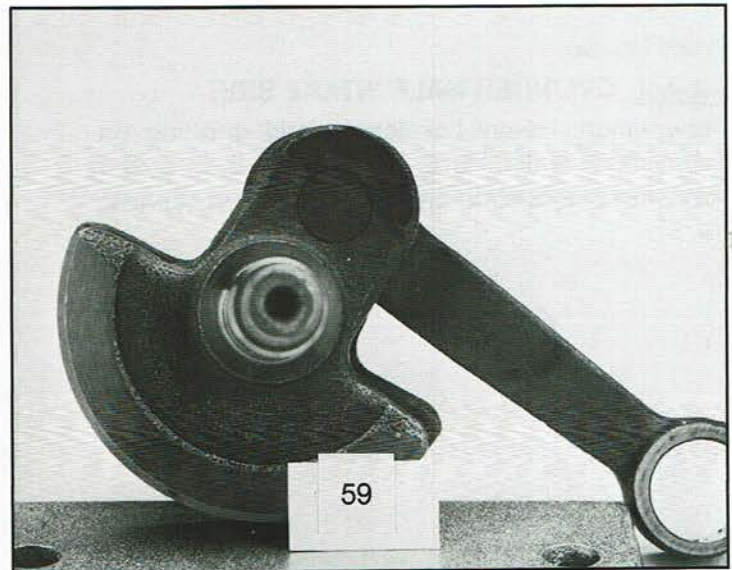
Photo No. 59

Subject: **CRANKSHAFT THREE PIECE TYPE**

Observation: Heat build up on the crank pin and lower connecting rod.

Cause: Center line of the crankshaft is twisted.

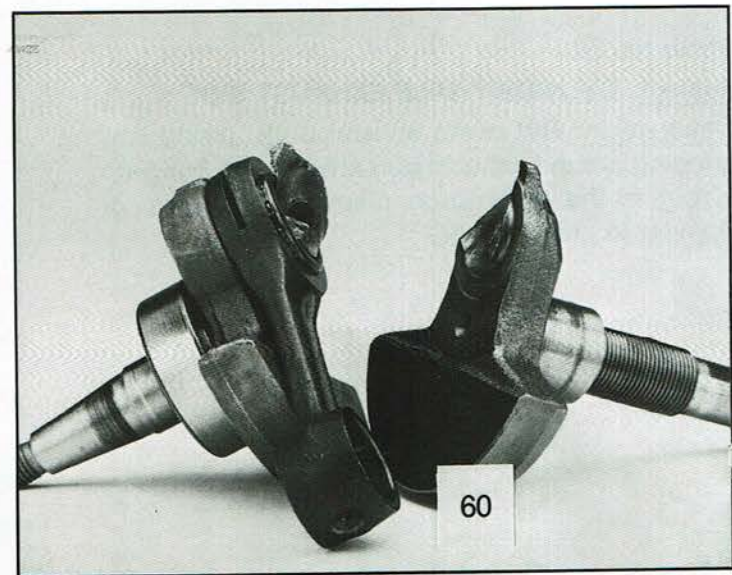
Photo No. 60

Subject: **CRANKSHAFT TWO PIECE TYPE**

Observation: Crankshaft has snapped at the crank pin.

Cause: The engine has been revved beyond its maximum recommended speed the additional force has caused high speed flexing of the crankshaft until it broke.

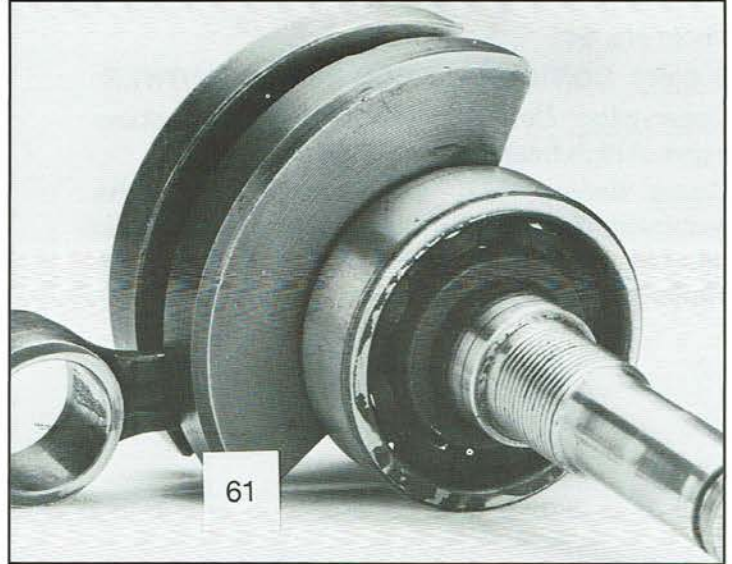
Photo No. 61

Subject: **MAIN BEARING, CONNECTING ROD AND BEARING RACE**

Observation: Bearing is coated with baked on dirt and carbon, bearing surfaces are rough, bearing race surface are pitted.

Cause: Engine has ingested dirt.

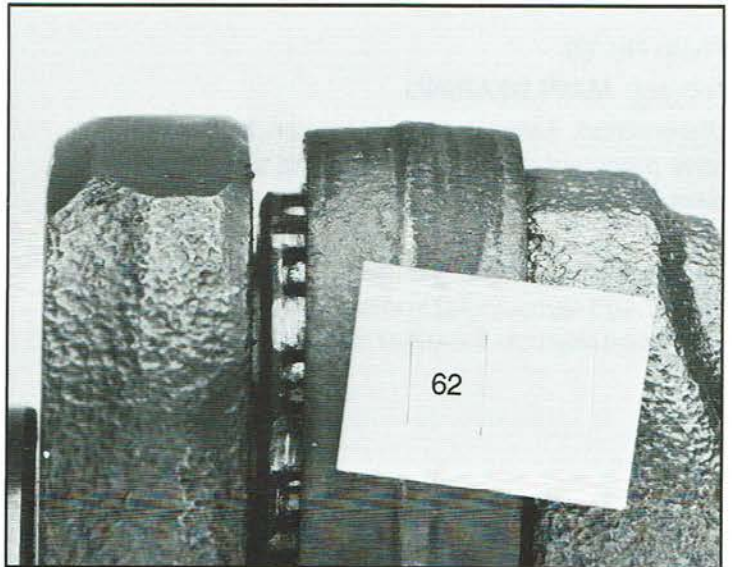
Photo No. 62

Subject: **BEARING LOWER CONNECTING ROD**

Observation: The rod bearing cage is being worn away.

Cause: Dirt ingested into the engine will eventually cause cracking or skidding (flat spots) of the bearings. This causes a build up of heat leads to the failure of the bearing.

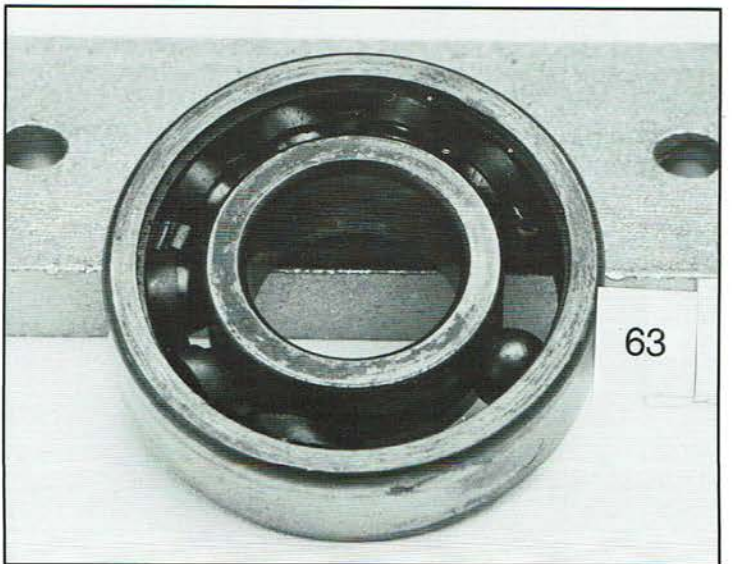
Photo No. 63

Subject: **MAIN BEARING CRANKSHAFT**

Observation: Bearing is darkened from severe heat, cage is distorted.

Cause: Engine has been revved above its maximum recommended speed resulting in overheating and a lubrication breakdown.

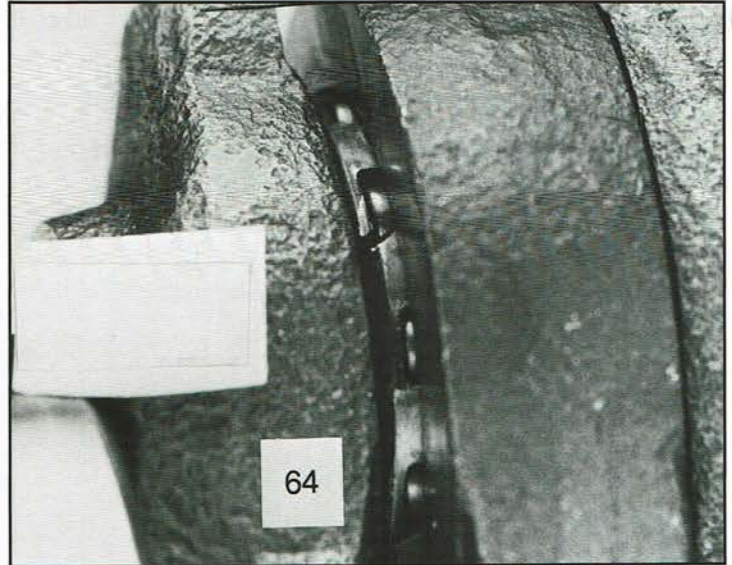
Photo No. 64

**Subject:** CONNECTING ROD BEARING, LOWER

**Observation:** Connecting rod and stroke pin show signs of high heat. Bearing cage is cracked.

**Cause:** Engine has been run above the recommended maximum speed. The resulting heat has caused the lubrication to breakdown, cage fracture from load.

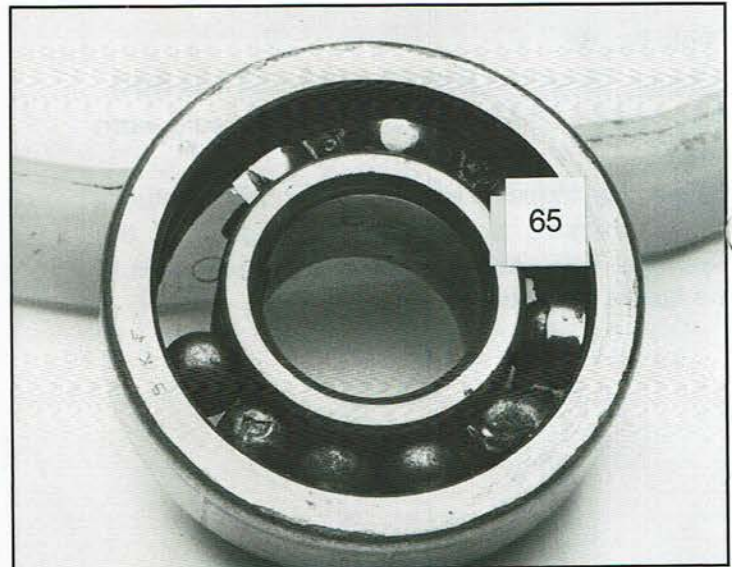
Photo No. 65

**Subject:** MAIN BEARING

**Observation:** Bearing cage is broken, ball bearings have pieces of material missing and are pitted and have flat spots.

**Cause:** Engine has been ingesting dirt, the dirt has collected in the bearing races and causes the balls to skid and develop flat spots resulting in heat and increased load on the other balls.

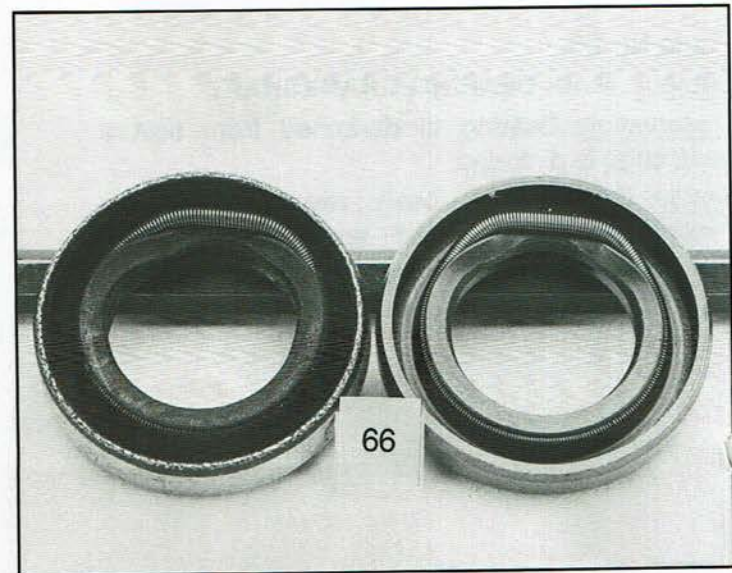
Photo No. 66

**Subject:** SEALS

**Observation:** Seal on the right is new, seal on the left has been leaking.

**Cause:** Dirt ingested into the engine will wear the seals away, seal spring damaged or missing.

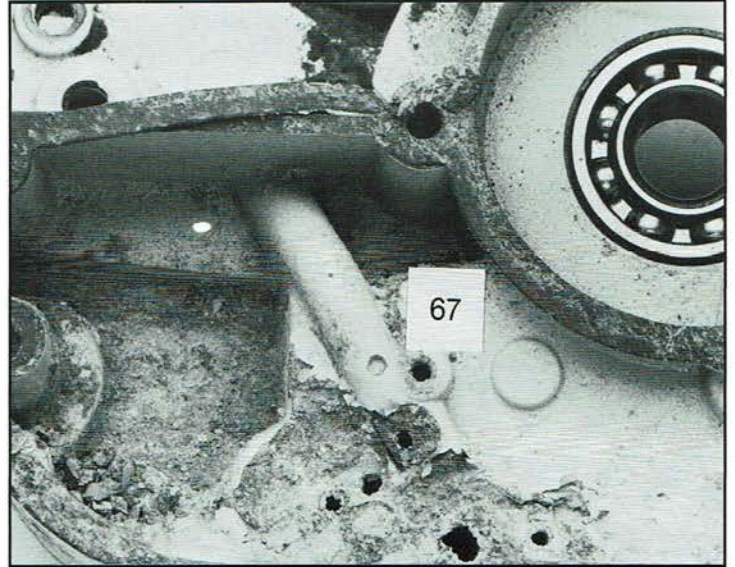
Photo No. 67

Subject: **MAGNESIUM TANK**

Observation: Material crumbling.

Cause: Corrosive substance in contact with magnesium. Corrosive substances include palm tree sap, alcohol, water, acids used in re-refining used oils for some types of bar/chain oils, some agricultural products including lime.

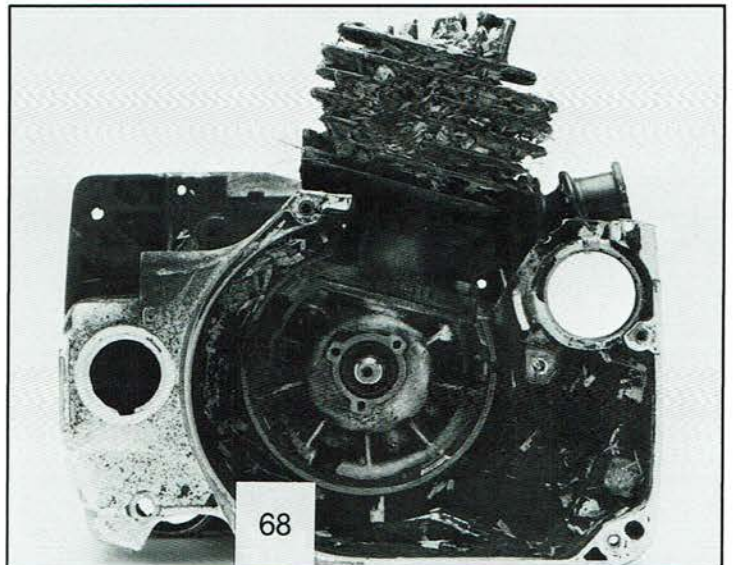
Photo No. 68

Subject: **CRANKCASE WITH CYLINDER**

Observation: Cylinder fins are packed with sawdust and chips.

Cause: Operator has not cleaned saw. This resulted in extreme heat buildup in engine. This causes seized pistons, broken bearings, detonation and lubrication breakdown.
