Diagnostics

DIA 207 Failure Analysis Examples

The following pictures and explanations are meant to give the service technician some examples to use for comparison or to better understand how faults can lead to failures.

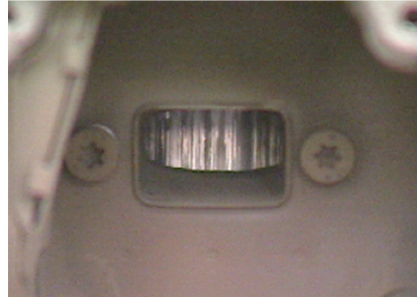
- If the piston is scored major repairs will be necessary
- To know for sure what the cause of the failure is, the STIHL Engine Check procedure should be used, if possible, to verify the presence or absence of any faults
- Once all faults on the engine are known, the exact cause of a scored piston can be determined

If the exhaust side is scored or in bad shape, this is most likely the reason why the unit doesn't run, or runs poorly.

The next step is to determine why it is scored.

Look for excessive carbon buildup and be sure the rings are free in the piston.

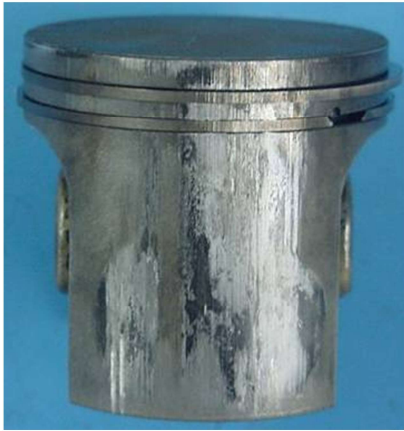
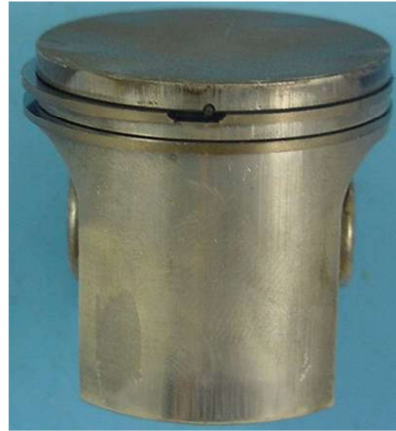
Lean Running

- Chain Saw - Damage is typically concentrated on the exhaust side
- Little or no damage on the intake side

In the combustion chamber, lean is lean; it does not matter if air entered the engine somewhere other than the carb, leaning out the mixture, or if the fuel flow was restricted, leaning out the mixture. If the engine does not have a rev-limiter, lean running will cause over-revving. A saw with a lot of run time will get a polished, buffed appearance on the bottom of the intake skirt, but over-revving will advance this buffing effect considerably, as the picture on the right indicates.

Fuel provides piston cooling, so a lean mixture allows the piston to overheat. However, damage is usually worse on the exhaust side.

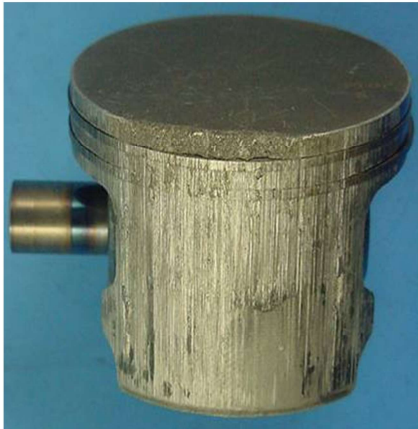
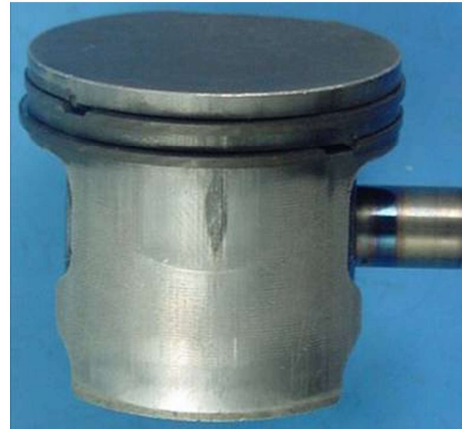
- Detonation is due to lean combustion
- Lean combustion can be caused by many things

When an engine is running lean, less fuel is coming into the combustion chamber to vaporize and extract heat, and what fuel is present will burn extremely fast. If conditions are right, detonation may occur, which will be evidenced on the exhaust side of the piston by the pitted, eroded areas where the piston is actually burned away.

When you see detonation burning of the piston, it is most likely caused by lean running. The fuel filter or tank vent may be restricted, or there may be an air leak in the crankcase. In some cases it may be due how the unit was operated. A chain saw being constantly operated in a part throttle RPM range may run lean and hot, and in some cases fail, even though there is no actual fault with the unit.

Typically, lean running damage will be concentrated on the exhaust side of the piston. There may be some scoring on the intake side if the unit runs long enough for the damage on the exhaust side to push the piston back against the intake side of the cylinder.

A STIHL Engine Check should identify some sort of lean fault, which would be confirmation of why the piston is damaged.

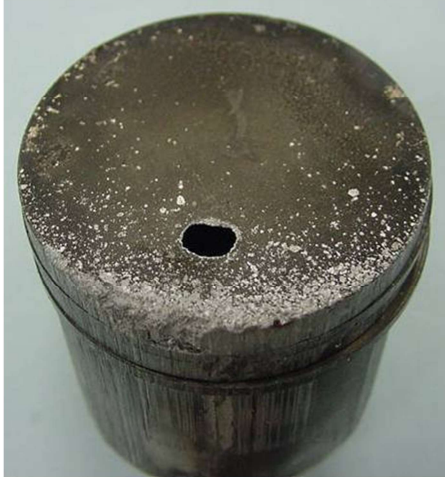
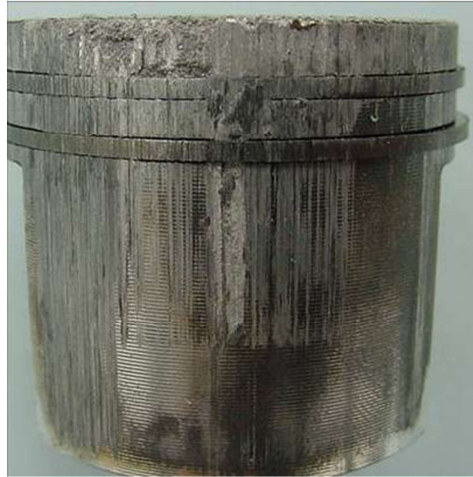
Other Failures: MS 180 Used for Carving

The STIHL Engine Check found no faults on this saw, which had less than 20 hours of run time on it. Detonation damage like this is almost certainly due to lean running conditions, yet none were found. When the operator was questioned as to how the saw was being used, it was explained that the saw was being used for artistic carving. This engine was seldom being held at WOT, and the throttle was constantly being “blipped” open and held in the mid range RPM to do the carving, which puts the engine in a lean running state most of the time.

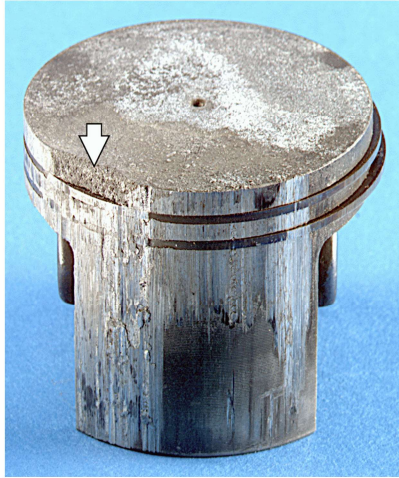
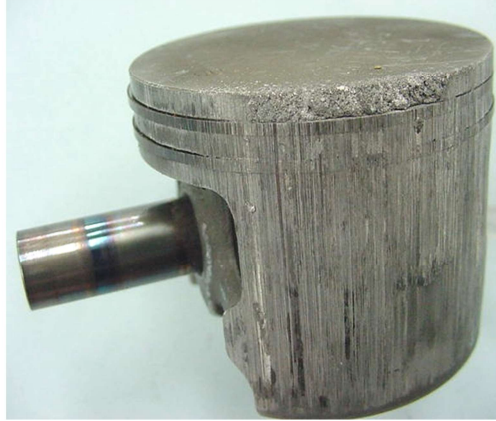
Detonation Damage

Detonation will cause the piston to actually melt and burn away, and a considerable amount of metal transfer will then occur between the piston and cylinder wall.

These examples show the burned edge and damage that is typical of detonation. Detonation is nearly always caused by lean operating conditions, so if the engine is to be repaired, the cause of the lean operating condition must be located and corrected.

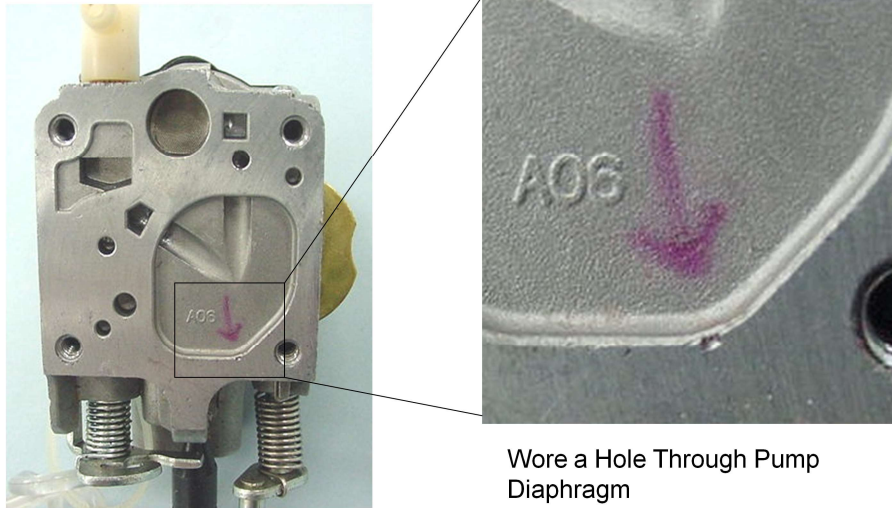
This carb failed the pressure test, and was leaking out the impulse hole, which is actually a rare fault. A machining flaw caused a nick in the milled surface of the carb body which rubbed a hole in the diaphragm. This is an example of a defective part and would be covered under warranty.

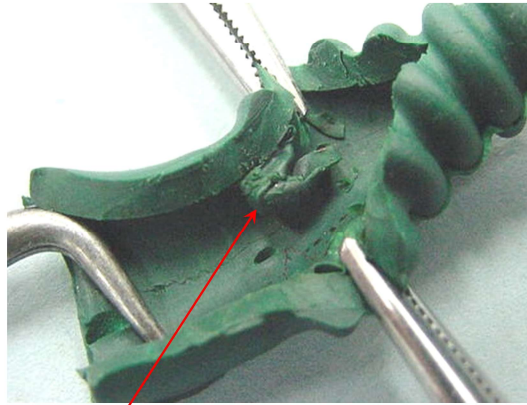
Lean Running Condition at WOT BG 55

Molding Flaw Restricted Fuel Flow at WOT

This fuel line was installed on a BG 55 blower. The dealer stated that when it was set up, that it would start and idle fine, but would go lean at WOT. The carburetor was the first thing checked and no faults were found. By process of elimination it was discovered that the engine ran fine once the fuel line was replaced. The cut open end was at the carburetor fitting, and the flap of material flash would restrict fuel flow enough at WOT to cause the engine to run lean. This is a very rare fault and was challenging to locate but in some cases a process of elimination may be necessary to locate the fault.

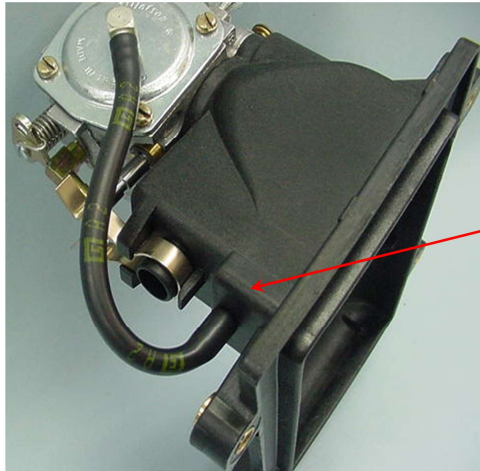
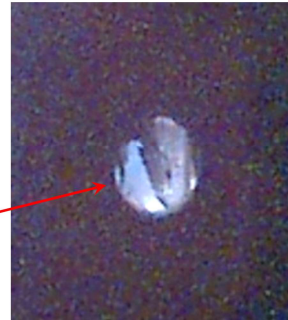
Thin Plastic Flash in Port
Caused Lean Running at WOT

If an air filter becomes restricted, it will cause the engine to run rich. The compensator carb design allows the engine to run with the mixture being leaned out automatically, up until the point that the filter is so restricted that the operator notices that the engine has poor performance. The picture shows a new filter housing where some plastic flash was covering the compensator port. This caused the carb to respond as if the filter was dirty, so the engine ran lean, even though the filter was clean.

The first thought would be a fault in the carb, but that wasn't the problem. Understanding the systems on a machine and how they work is very important when troubleshooting a running problem. The technician found that when the compensator hose was removed from the filter housing the engine ran fine.

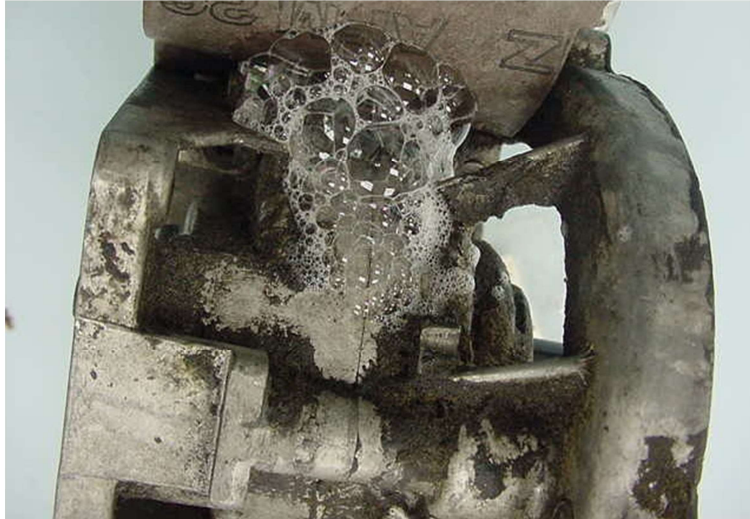
4137 Crankcase Leak

When the engine was vacuum tested it failed. Then when it was pressure tested, it also failed, and soapy water indicated that the crankcase was leaking along the seam.

A leaking crankcase can be compensated for by tuning the carb rich. But the unit will not perform well under load and may have erratic idle from one day to the next.

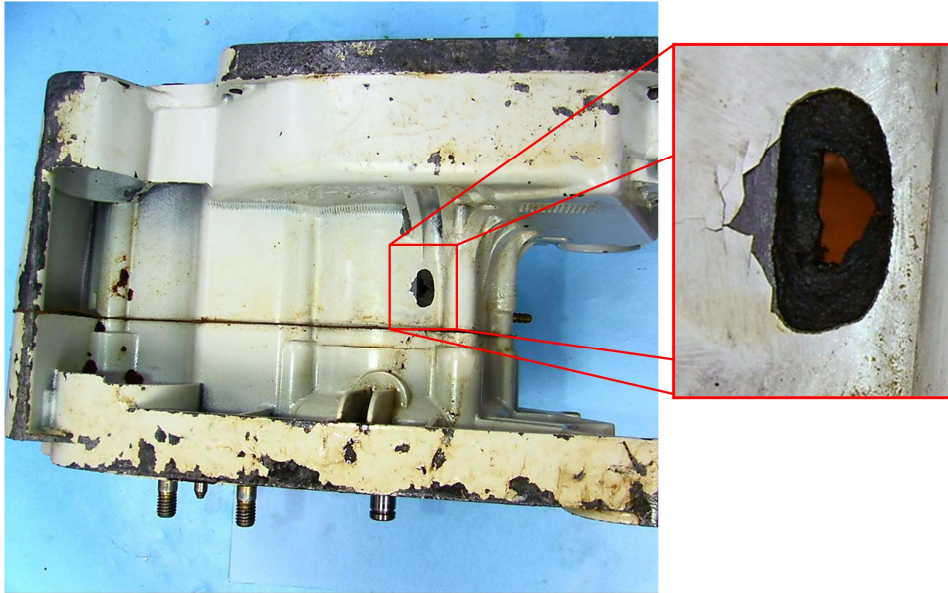
066 Failure, Repair, and Failure Again

The saw was brought in for repair. It quit in the cut and would not start. Compression was low so a new piston and cylinder was installed, the carb tuned but no test cut was made. The customer paid the \$500 repair bill and took the saw home to use. The saw failed again in the first cut. When returned to the dealer a second piston and cylinder was installed at no charge. When the customer got home and used the saw it failed again in the first cut.

The carb was adjusted rich and masked the leak with no load on the engine but once it was in the cut the air leak in the crankcase leaned out the air-fuel mixture enough to cause the engine to fail.

The first failure damaged the piston so severely a piece of the skirt got caught between the crankshaft and the case and knocked the hole through the bottom. Had the pressure test been done to the crankcase before the first teardown this would have been found, and two piston and cylinder assemblies would not have been wasted as well as the time and effort to install them.

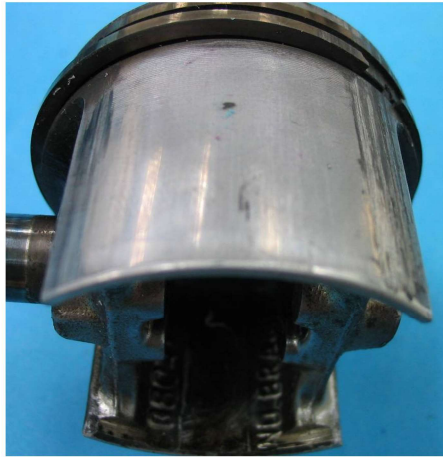
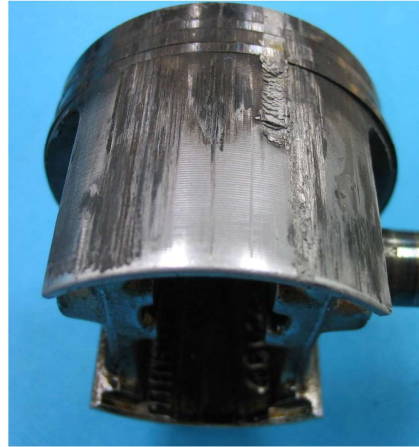
Overheating Failure

- Overheating led to swelling through the ribs of the piston, pushing out the skirt at the corners

This chain saw was being used for limbing. The operator had a long coat that was being sucked up against the starter side air intake, restricting the airflow. The oil molecules burn off at high temperatures, and the piston swelled at the rib areas, causing seizure. Notice that there is no evidence of detonation. Sometimes you will see a typical three or four point scoring in the areas of the piston skirt ribs, as the piston swells more in that area due to the thicker amount of material. If the engine runs long enough, the exhaust side may score all the way across, but the intake side will usually only have the 2 scores at the rib area, or show some push over scoring directly opposite heavy damage on the exhaust side.

A typical overheat failure will usually have some scoring on the intake side at the ribs, and there will usually be some melt damage to any plastic near or touching the cylinder.

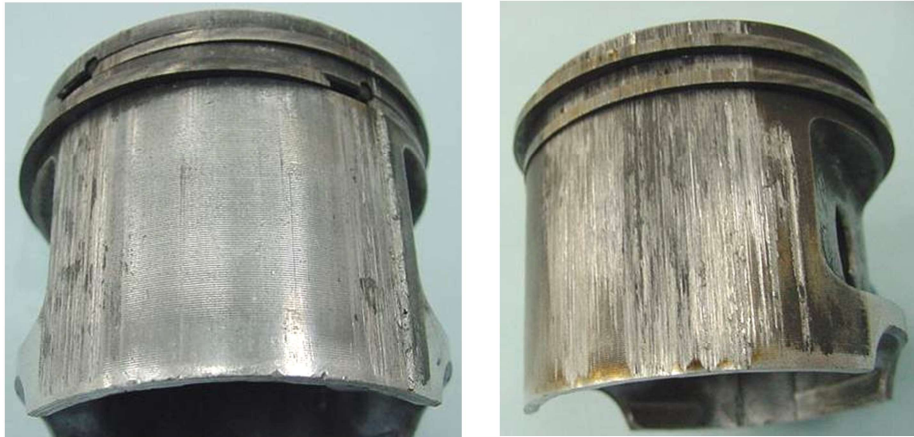
- Overheating led to intake scoring top to bottom at ribs
- Exhaust is scored all the way across due to multiple seizures

If the engine was allowed to cool and then the engine restarted, multiple layers of scoring may be present, indicated by blackened areas with fresher, shiny scoring on top. It is also common to see a buildup of scoring on the exhaust side to push the piston over against the intake side of the cylinder wall and cause scoring in the middle of the intake side of the piston.

Again, the clue that overheating may have happened is the 3 or 4 point scoring in the rib area of the piston. There was also melt damage to the shroud which would not have happened if the blower was operated on fuel with no oil in it.

No evidence of lean running was found, or any other major faults, but there was some leaf residue in the bottom of the impeller housing. This failure occurred in the fall, after large leaves start falling and these machines start seeing more run time. It is likely that some leaves got drawn up behind the back plate and partially blocked the air intake. Because the BR 420 engine is cooled from the impeller housing, this may have been what ultimately led to the failure.

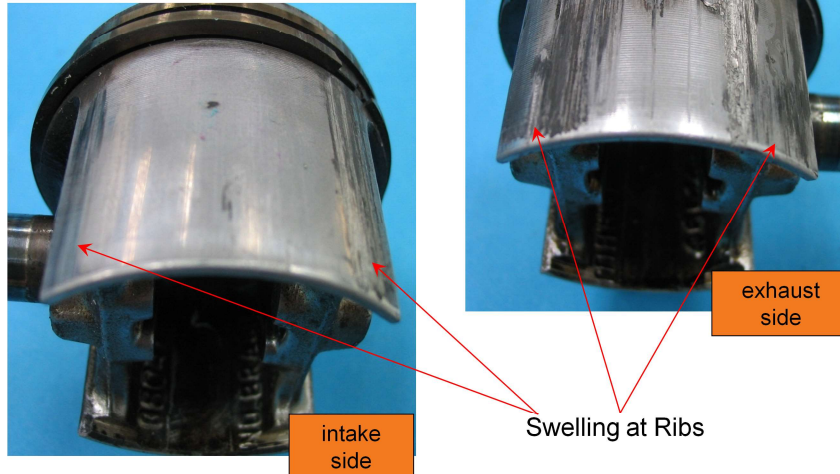
This is sometimes referred to as “4 point scoring”, implying that the piston swells at the four corners where the support webs for the skirt are located.

Typically, the exhaust side of the piston will be scored all the way across, with the intake side showing damage mainly at the skirt webs.

The wrist pin will usually be blue, and the underside of the piston may be black with burned oil residue.

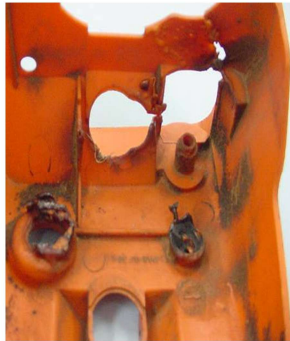
Overheat Damage

- Melted plastic will typically only happen in an overheat situation
- A careful inspection may be needed to verify if there is any melt damage on the unit

Sometimes melted plastic will be obvious, while other times you may have to look carefully or remove shrouds or other parts to locate any damage.

Melted plastic on or near the cylinder is proof the engine saw abnormal operating temperatures. An engine failure due to a lean fault, or operated on un-mixed fuel, or allowed to ingest dirt will never get hot enough to melt any plastic.

Overheating may cause the crankcase to develop an air leak which would be found when doing the pressure/vacuum test, but if melted plastic is present now we know the crankcase air leak did not cause the failure but is the result of an overheating situation.

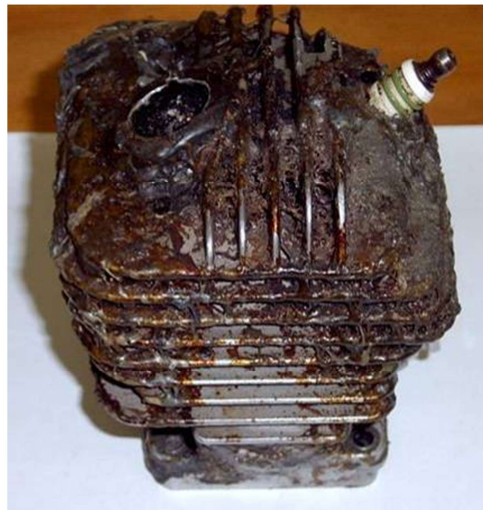
Overheat Causes

- Sometimes the reason for an overheating situation is obvious, sometimes it is not

The MS 192 in the upper picture was used to trim palm trees and the fine fibers completely blocked the airflow under the starter housing. This is a maintenance concern that is the operator's responsibility.

The cylinder on the right is from a MS 660, used to cut 55 gallon plastic barrels in half. Using the saw this way allowed the engine to run at full throttle under basically no load, so the RPM was excessive. The plastic pieces from cutting the barrels accumulated under the shroud and melted into a mass that obviously led to overheating and failed the engine.

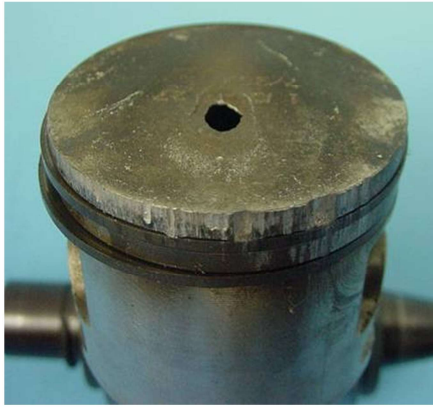
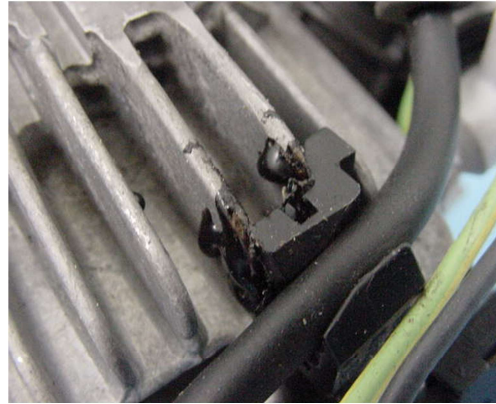
MS 211 Overheat Failure

- Overheating led to abnormal combustion

Stratified scavenge engine designs may not show the typical four corner scoring that a conventional piston port engine does. This MS 211, when overheated, caused detonation in the combustion chamber which damaged the exhaust side of the top of the piston and also overheated the spark plug which caused pre-ignition. Pre-ignition then caused a hole to burn through the top of the piston where it is very thin.

At first glance this might seem like a lean running fault, but it is lean running caused by overheating which led to vaporizing of the fuel in the crankcase and abnormal combustion in the combustion chamber.

Lean running alone would not get the engine hot enough to melt the spark plug lead clip that is attached to the top of the cylinder. The shroud is not damaged because it does not contact the cylinder.

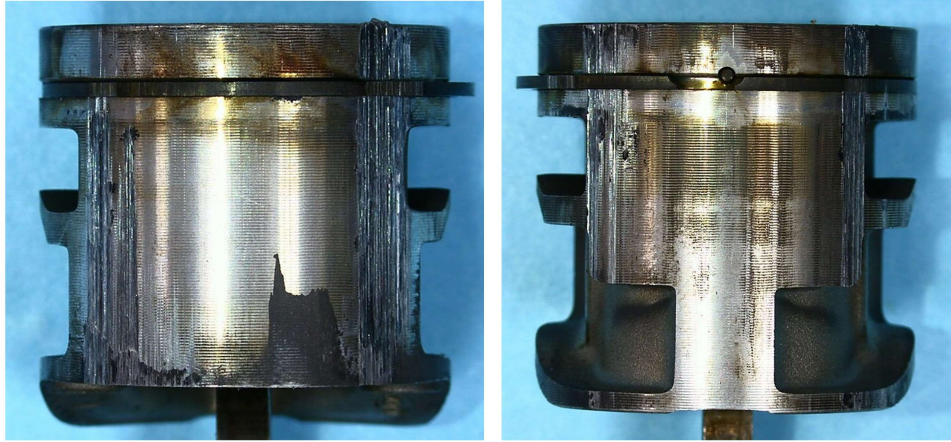
This is a stratified charge engine design with the control recess on both sides of the piston skirt on the intake side. This design has a longer skirt on the intake side and has more material spread out as part of the skirt than a conventional piston port two-stroke does.

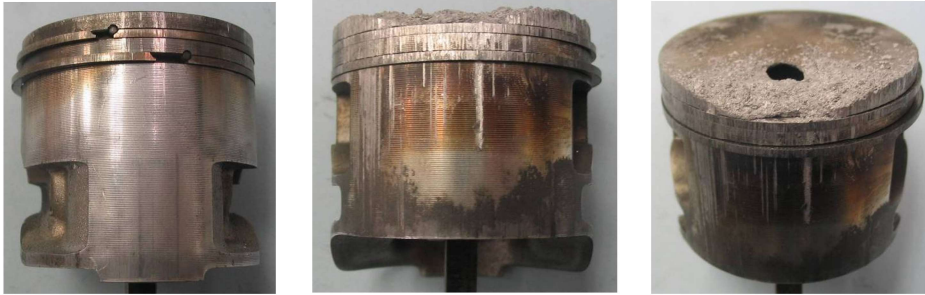
1139 Series MS 211 Overheat Failure

- The cooling air was restricted through the starter side of the unit
- Notice that the intake side does not show the same sort of corner scoring as a conventional piston port design usually shows
- There is more skirt to spread out the heat, and the detonation damage caused the engine to stop running before any further skirt scoring developed

In some cases an overheat situation may lead to heat buildup in the fuel tank and carburetor, which may cause a vapor lock situation in the fuel system. This leads to lean running in the combustion chamber.

Most small saws today use a lightweight piston with a thin crown, to provide less reciprocating mass at high engine speed. A lean running condition in the combustion chamber can lead to detonation and pre-ignition and result in piston failure such as this picture shows.

The STIHL Engine Check did not find any obvious lean faults, but the spark plug wire clip on the top of the cylinder was melted, which would not have happened if lean running was the only fault that caused piston damage.

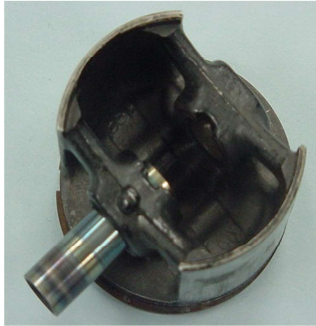
Black Underside of Piston
Wrist Pin Blue

Exhaust Scored Across Top, and to the Bottom at Ribs

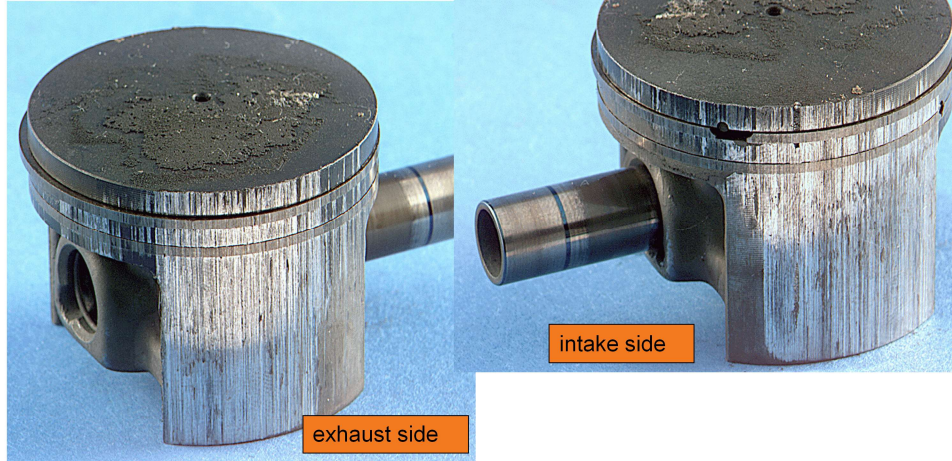
- Piston May Be Discolored, Scoring Evident Up To 360°

Typical damage from lack of lubrication will be up to 360° scoring around the piston. It may be due to no oil, the wrong type of oil, or not enough oil in the fuel. Old fuel may also contribute to this.

Winter fuels or fuel with high levels of alcohol may indicate failures similar to those observed from lack of lubrication.

If a STIHL Engine Check is done on the engine and no lean faults or overheat indicators are found, then the piston is removed and has scoring on both sides or even all the way around, it is most likely a lack of lubrication related failure. The only way to be sure is to see what faults are present, and if none are found then by process of elimination, it is most likely lack of lubrication.

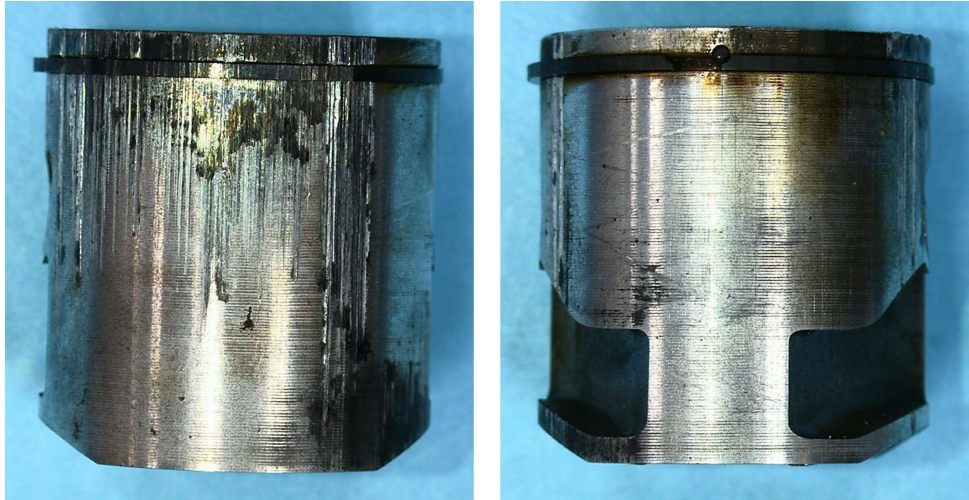
This is a stratified charge engine design with the control recess on both sides of the piston skirt on the intake side. This design has a longer skirt on the intake side and has more material spread out as part of the skirt than a conventional piston port two-stroke does.

There was no melted plastic evident nor were there any faults such as dirt ingestion or air leaks.

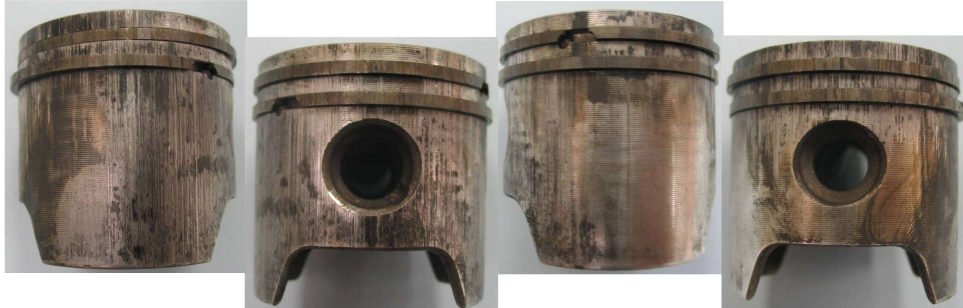
- This unit had several tanks of mixed fuel ran through it
- It would not re-start after 1 1/2 tanks of un-mixed fuel

This engine only lasted 1^{1/2} tanks before the damage was severe enough to cause the engine to lose compression. If the engine has a residual oil buildup from being operated with a quality oil at the right ratio, it may extend how long the engine will survive.

The STIHL Engine Check showed no faults. If the customer is told that the unit was operated on fuel with no oil in it, and that is why the engine is damaged, the service technician needs to be able to prove it. Showing the customer the completed evaluation worksheet, and being able to say that the unit was carefully examined and no obvious faults are present, yet the piston is scored nearly everywhere, gives good evidence that lack of oil is the cause of failure.

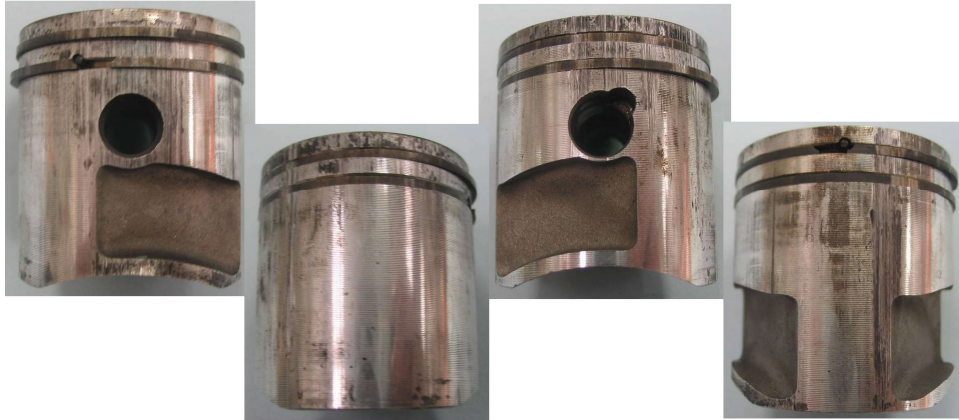
- New unit with no run time, started on un-mixed fuel, throttle locked at WOT, ran for 3 minutes and would not re-start

This engine had no residual oil soaked into the metal surfaces, so it did not last very long.

This is a stratified scavenge engine design. Notice that the lack of lubrication caused scoring on the intake and both sides of the piston first and led to a loss of compression when the rings were pinched by the material wiping across the lands.

The crankshaft bearings are fine, and all it would take to repair the unit is a new piston and cylinder assembly.

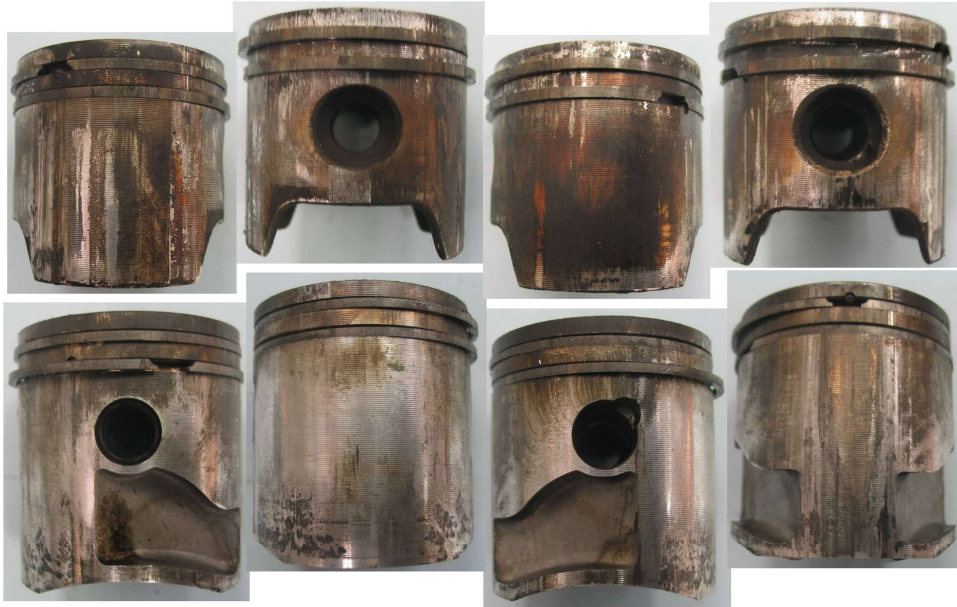
Both of these trimmers had several tanks of mixed fuel ran through them, and then each was operated on fuel without any oil. The FS 55 ran through seven tanks of un-mixed fuel before it would not restart. The FS 70 stopped on the third tank of un-mixed fuel.

Again we see damage spread all the way around the piston skirt.

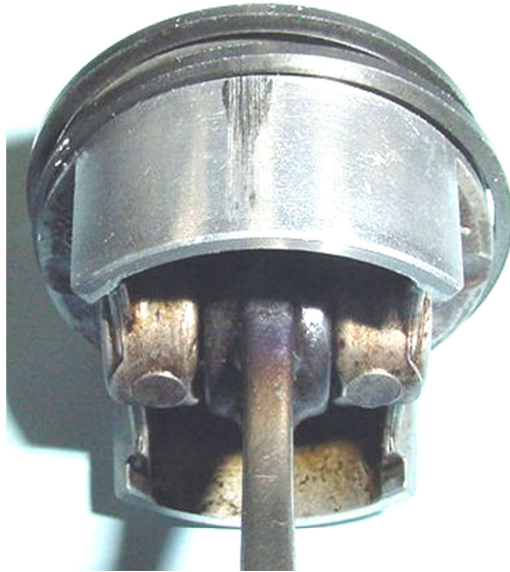
Notice the blue discoloration on the connecting rod. The piston is seized to the wrist pin, and will not rotate at all. There is a slight amount of scoring on the piston.

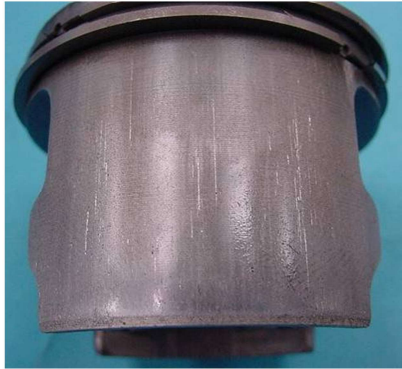
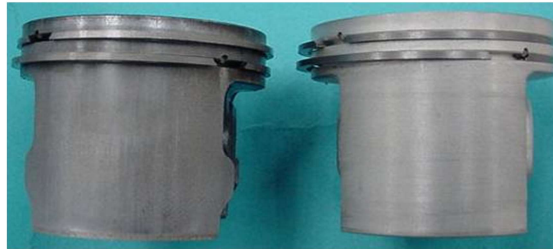
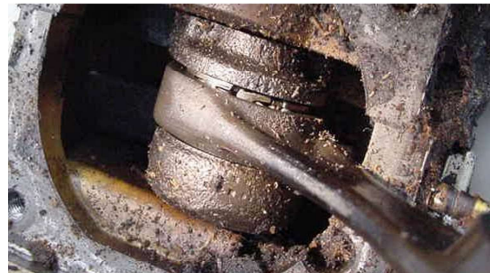
- There will always be evidence of dirt on the clean side of the air filter

Notice the sandblasted, dull look of the intake side of the piston on the left, compared to the one on the right. In the close-up, you can see the scratch marks and tell that the machine marks are worn off. An engine with long term dirt ingestion may continue to run until it has so little power that the operator will complain about the performance. The dirt may cause the lower rod bearing to fail since that is the first place it hits as it comes into the crankcase.

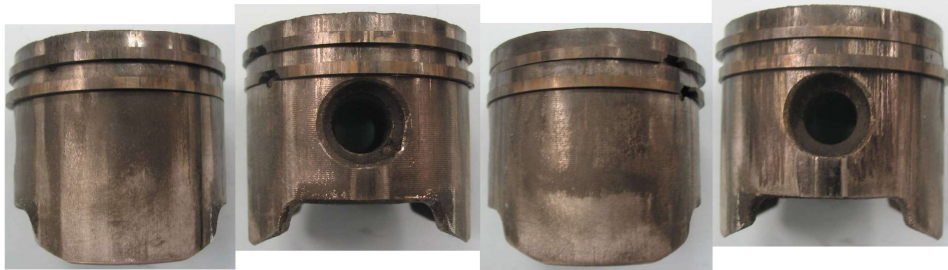
New	After Failure	Difference
■ Ring end gap:	0.011"	0.021"	0.010"
■ Piston Skirt diameter:	1.337"	1.330"	0.007"
■ Crankshaft side play:	0.000"	0.011"	0.011"

This FS 80 was operated on several tanks of mixed fuel, then had a measured amount of fine grit fed slowly fed through the carburetor. It was operated for two tanks of fuel after the grit was introduced. The wear is worst on the intake side of the piston and the chrome is worn away from the cylinder on the intake side as well. Notice that the wear has affected all moving parts in the engine.

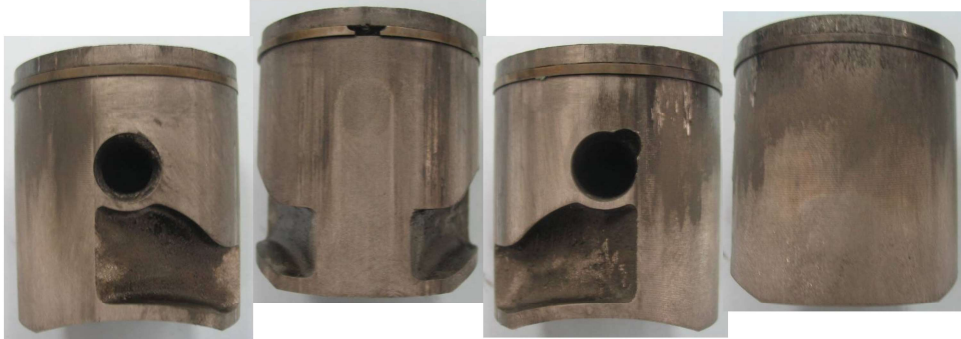
New	After Failure	Difference
■ Ring end gap:	0.012"	0.052"	0.040"
■ Piston Skirt diameter:	1.336"	1.330"	0.006"
■ Crankshaft side play:	0.000"	0.011"	0.011"

This FS 56 was operated on several tanks of mixed fuel, then had a measured amount of fine grit fed slowly fed through the carburetor in the same manner as the FS 80 on the previous page.

The FS 56 has a single piston ring and the dirt caused significantly more wear to the ring.

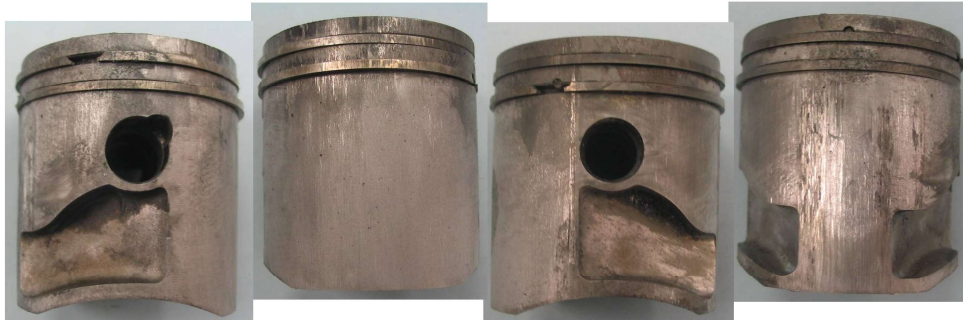
New	After Failure	Difference
■ Ring end gap:	0.012"	0.055	0.043"
■ Piston Skirt diameter:	1.336"	1.321"	0.015"
■ Crankshaft side play:	0.000"	0.011"	0.011"

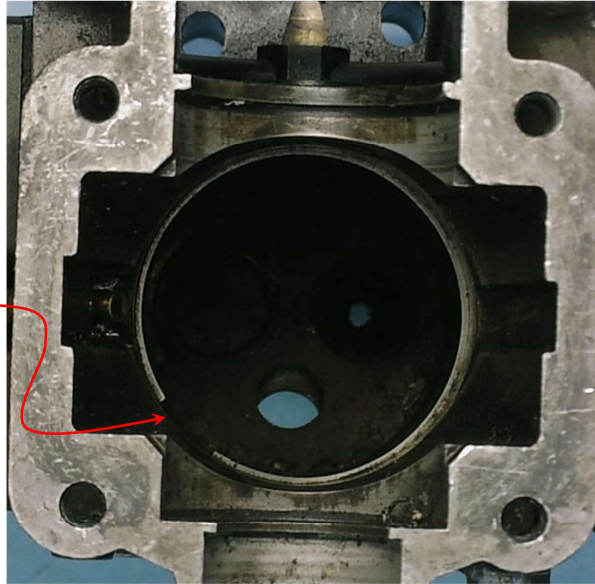
- Notice ring end gap:
3/8"

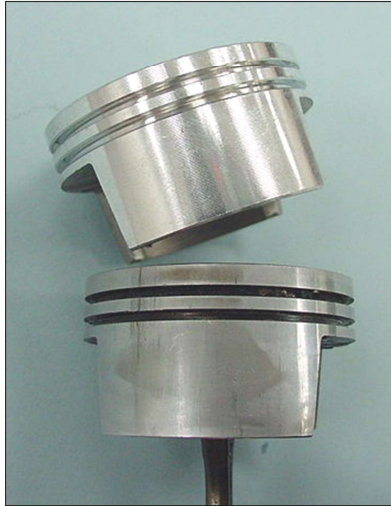
HT 100

Piston Wear From Dirt Ingestion

0.008" Measurable Wear on
Piston Skirt

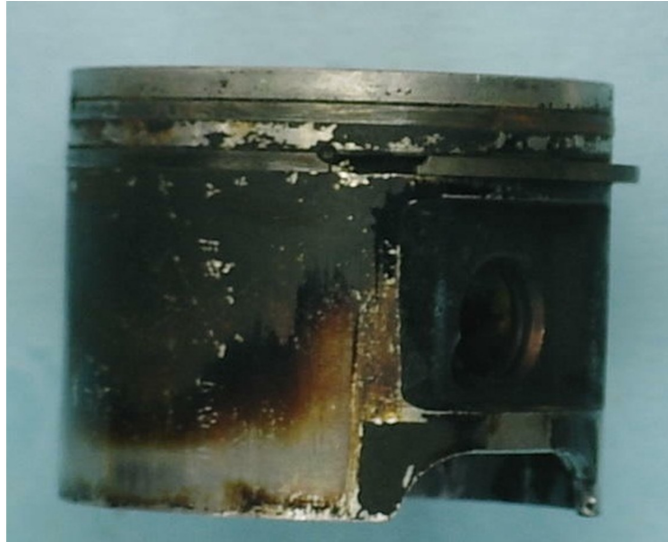
- Notice that the rings are stuck flush and the skirt is heavily coked with carbon

After 2 cords of wood he brought the saw to his dealer with a no start complaint. The saw had no compression due to the rings being carbon seized in the lands. Even a good quality oil will coke up and cause this sort of problem when mixed too rich.

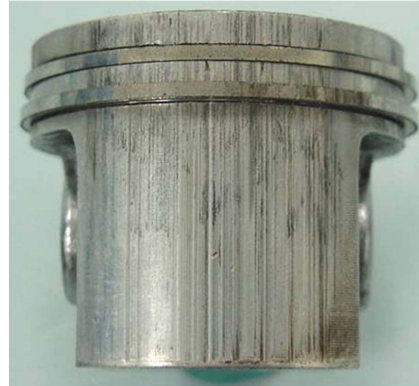
Carbon buildup in the exhaust port breaks off and is caught between the skirt and cylinder wall.

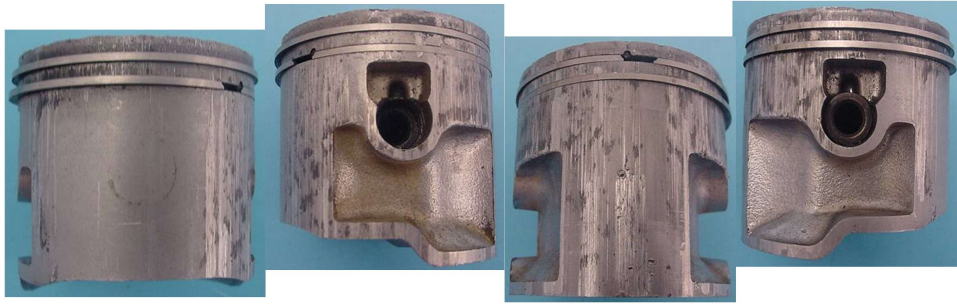
- This unit was being used to cut the bottom of a pipe in a hole with standing water, and the air filter was being submerged in the water which clogged up the filter

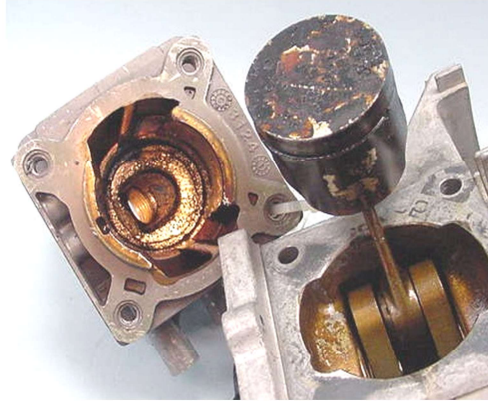
- This unit sat for 6 months
- The fuel oxidized and leaked into the combustion chamber and crankcase
- The engine was locked up and difficult to take apart

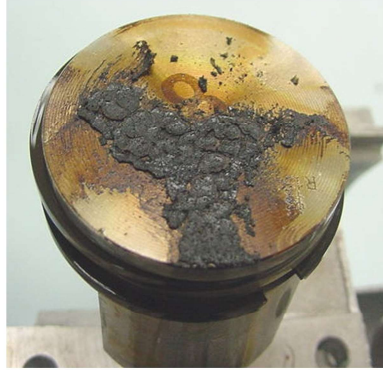
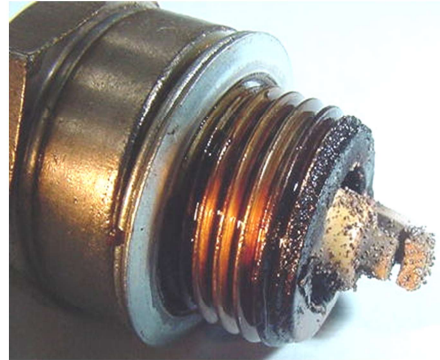
- This unit was operated on fuel that was over 6 months old
- It was hard to start and the mixture screws had to be opened to keep it running
- After 2 tanks of fuel the engine died due to a fouled spark plug
- Notice the heavy deposits on the piston and plug

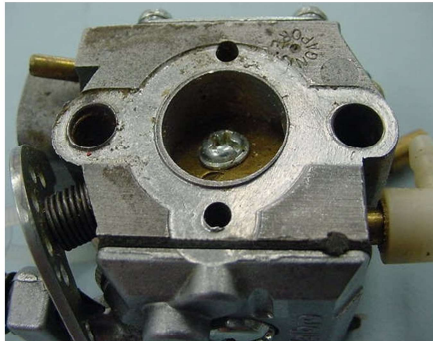
Operated With Mounting
Screws Loose

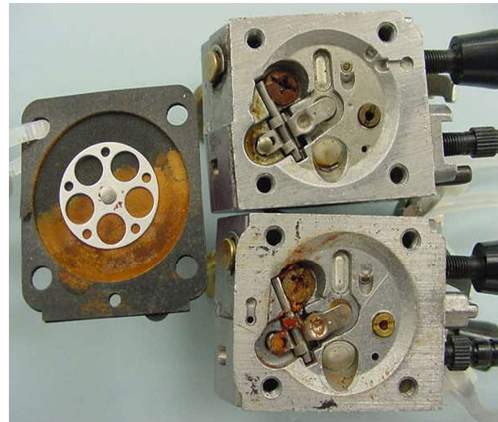
Evidence of Water in Fuel
