# Fault Analysis

2004-02

## Assessment of Damage

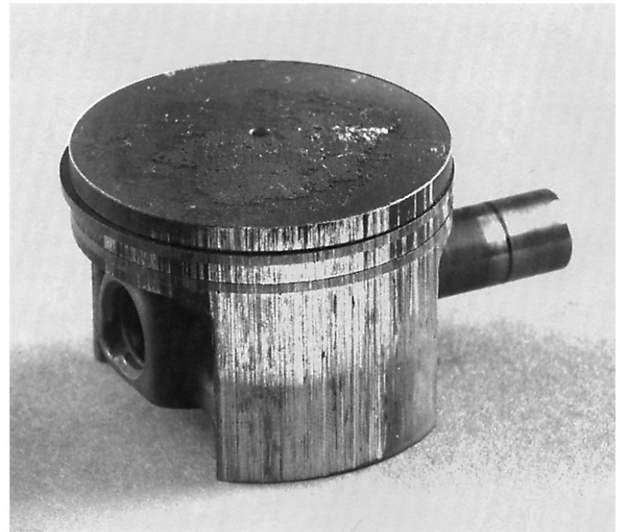
**Fig.:** Exhaust side

- 1.1 Location:** Running surface of piston  
**Condition:** Scores over entire running surface  
**Causes:** Incorrect fuel mixture
- No engine oil in fuel
  - Too little oil in fuel mix
  - Fuel old or of unsuitable quality

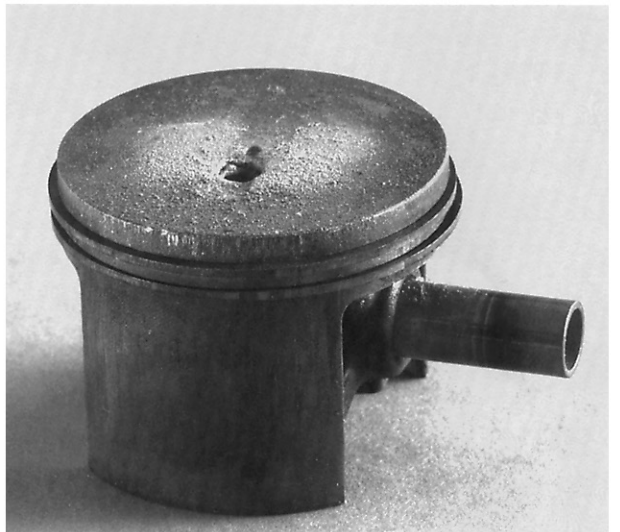
- 1.2 Location:** Piston head  
**Condition:** Burnt out  
**Causes:** Preignition as a result of
- Spark plug with too low a heat range
  - Fuel with too low an octane rating (< 90 RON)

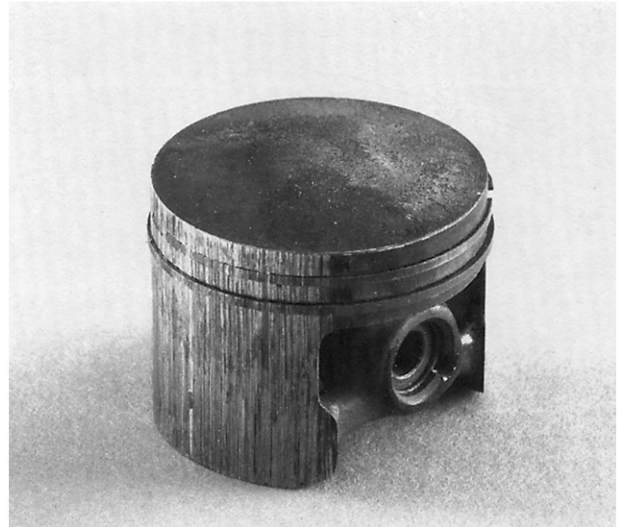
- 1.3 Location:** Exhaust side of piston
- Condition:** Scores over entire running surface
- Causes:** Inlet mixture too lean
- Fuel feed interrupted
  - Impulse hose dirty or leaking
  - Crank drive leaking
- Results in over-revving and insufficient lubrication.

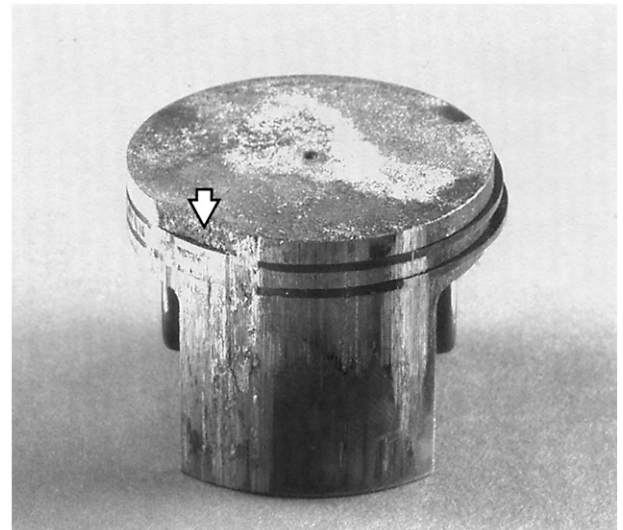
- 1.4 Location:** Exhaust side of piston
- Condition:** Scores over entire running surface
- Causes:** Thermal overload due to inadequate cooling
- Fan housing very dirty
  - Cylinder fins heavily loaded with dirt
- Results in overheating or seizure at front right next to muffler.

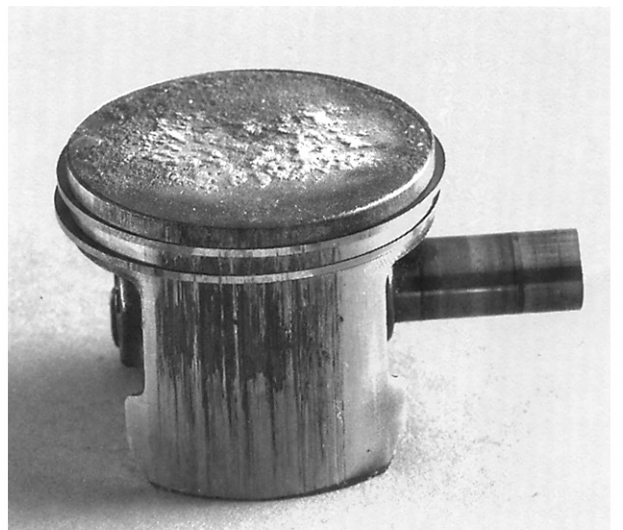
- 1.5 Location:** Exhaust side of piston
- Condition:** Scores and oil carbon residue over entire running surface
- Causes:** Unsuitable engine oil or over-rich carb setting causes excessive build up of carbon on piston head. Oil carbon can burn off as a result of an increase in combustion chamber temperature brought about by:
- Making carb setting leaner
  - Mixture becoming leaner due to air entering through a leak
  - Changing fuel mixture (e.g. to unleaded gasoline or synthetic engine oil)

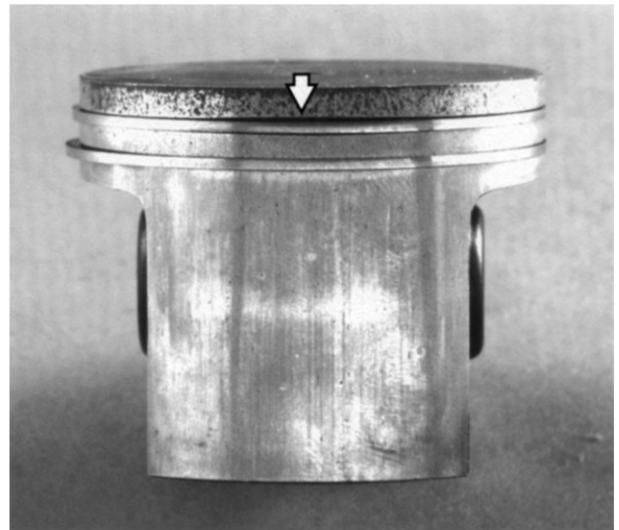
- 1.6 Location:** Exhaust side of piston
- Condition:** Worn running surface
- Causes:** Dirt particles and oil carbon in exhaust port have got between piston skirt and cylinder.

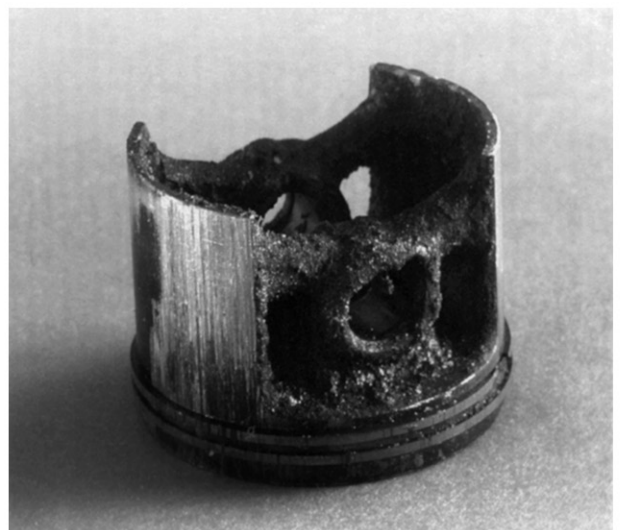
- 1.8 Location:** Interior of piston
- Condition:** Deposits
- Causes:** Chain lubricant seeps into crankcase or combustion chamber through a leaking joint and accumulates on piston and other parts of engine.

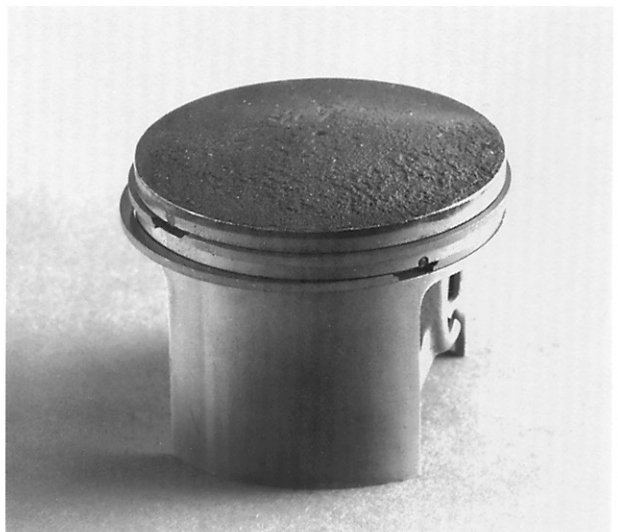
- 1.11 Location:** Inlet side of piston skirt
- Condition:** Dull running surface
- Causes:** Abrasive dust causes excessive wear on piston skirt and rings
- Remedy:** Check condition and type of air filter.

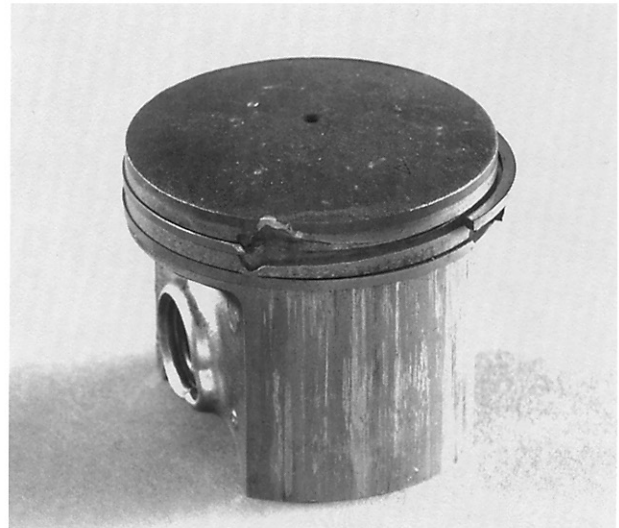
**1.13 Location:** Inlet side of piston

**Condition:** Piston ring broken

**Causes:** Ring severely weakened by wear

**Consequences:** Lack of control causes ring to break

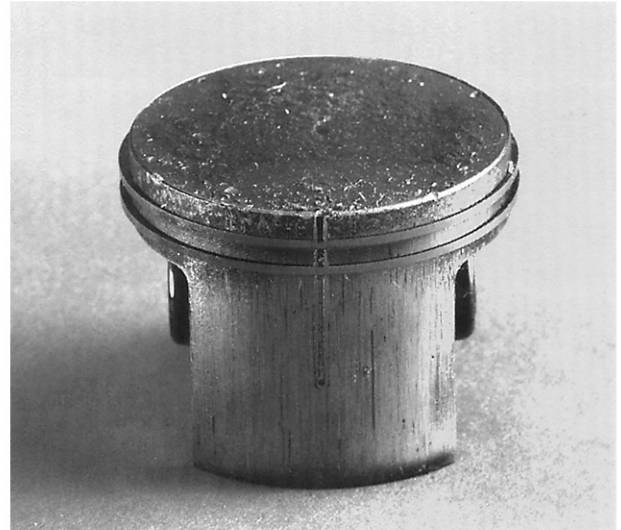
**1.18 Location:** Piston

**Condition:** Scores in running surface

**Causes:** Minute particles of faulty

- Main bearings
- Big-end bearing
- Small-end bearing

have got between cylinder wall and piston skirt

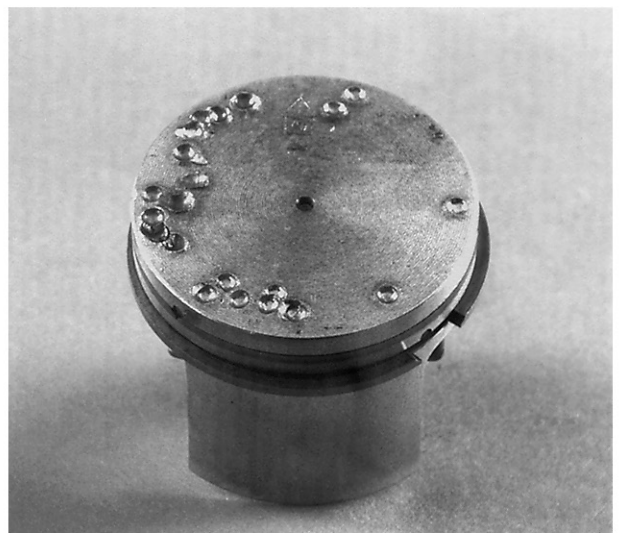
**1.20 Location:** Piston head

**Condition:** Indentations caused by impact with foreign bodies

**Causes:** Loose balls of main bearings have entered combustion chamber through transfer ports

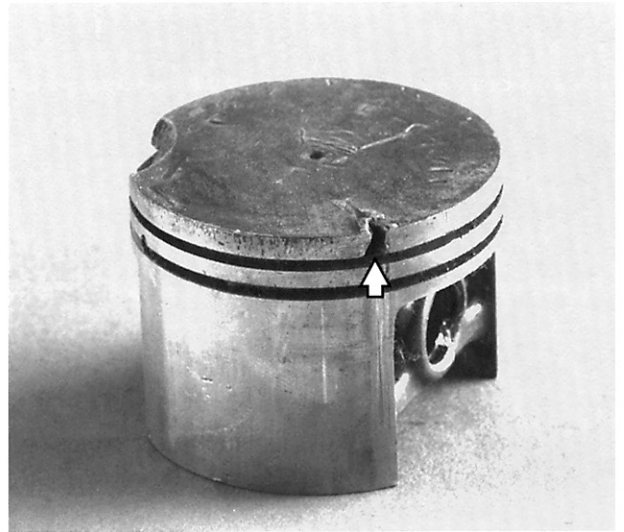
- 
- 1.21 Location:** Piston lands  
**Condition:** Ring retaining pin has loosened  
**Causes:** Retaining pin not pressed in correctly

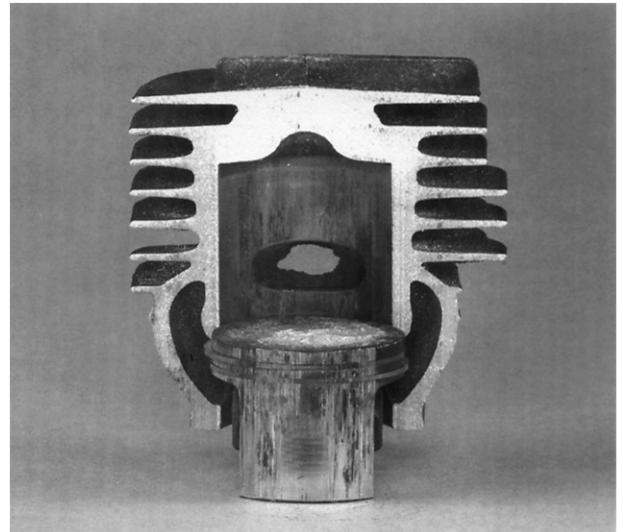
- 2.2 Location:** Exhaust port
- Condition:** Carbon deposits
- Causes:** Using unsuitable engine oil
- Consequences:** Interruption of oil film results in traces of friction on piston.

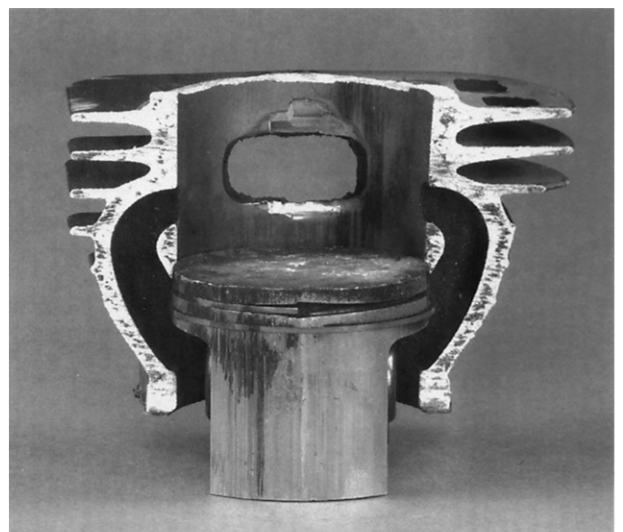
- 2.3 Location:** Exhaust port
- Condition:** Wear on edges of port
- Causes:** Broken piston ring has spread the piston ring groove and damaged the edge of the cylinder port

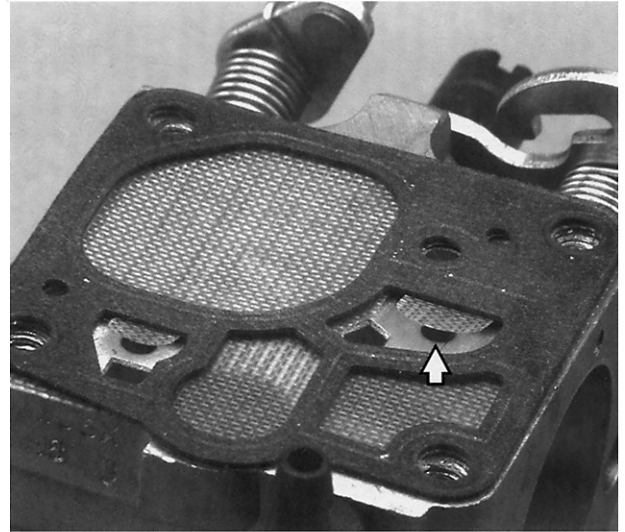
- 5.1 Location:** Fuel pump
- Condition:** Valve tabs in pump diaphragm do not locate properly. Pump ports are no longer sealed properly.
- Causes:** Valve tabs can deform after long period of service or as a result of using unsuitable fuel.
- Consequences:** Reduced pump output makes mixture too lean
- Engine running problems
  - Starting difficulties
  - Damage to piston

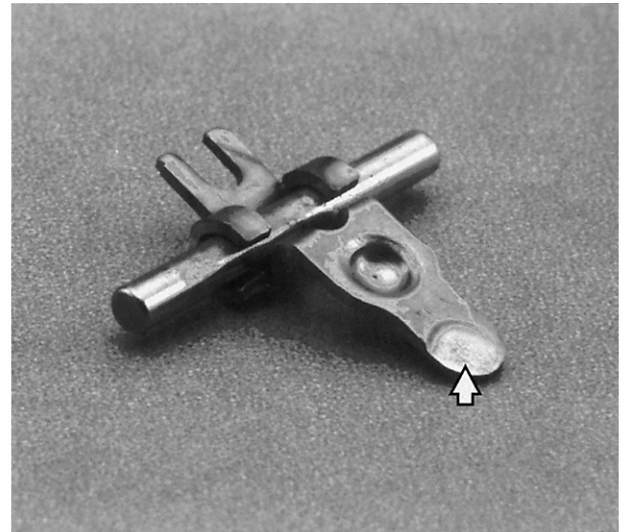
- 5.5 Location:** Inlet control lever  
**Condition:** Contact surface worn  
**Causes:** Mechanical abrasion due to
  - dirt particles in fuel
  - severe engine vibrations**Consequences:** Poor inlet flow control resulting in problems with engine idling behavior

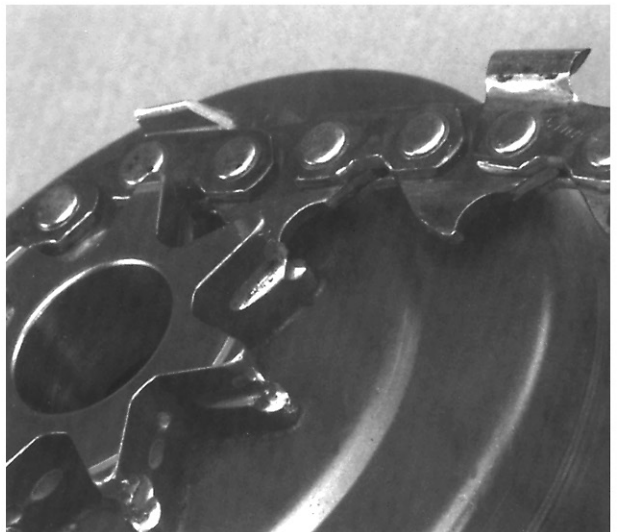
- 7.2 Location:** Cutters, tie straps and drive links
- Condition:** Wear and burrs
- Causes:** Worn chain sprocket
- Tips of drive link tangs hit bottom of sprocket
  - Tops of sprocket teeth cause abnormal wear in center of cutters and tie straps

**Fig.:** Worn spur sprocket

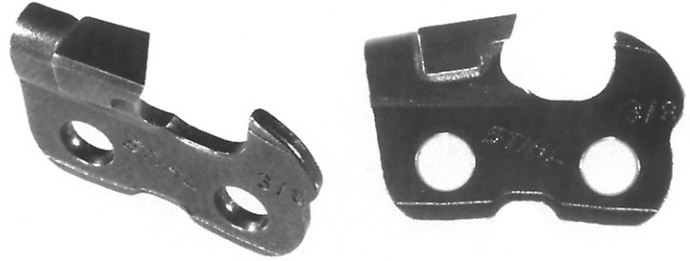
**Cutter in new condition**
