Diagnostics

DIA 207 Failure Analysis Examples

The following pictures and explanations are meant to give the service technician some examples to use for comparison or to better understand how faults can lead to failures.

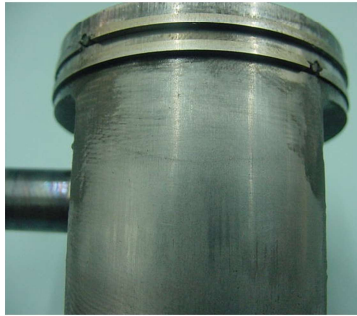
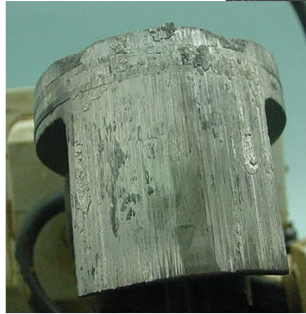
Detonation Damage

intake
side

exhaust
side

With less fuel available for combustion, the flame front speed will become excessive and may lead to detonation, usually concentrated at the exhaust side of the piston or under the spark plug.

Detonation will cause the piston to actually melt and burn away, and a considerable amount of metal transfer will then occur between the piston and cylinder wall.

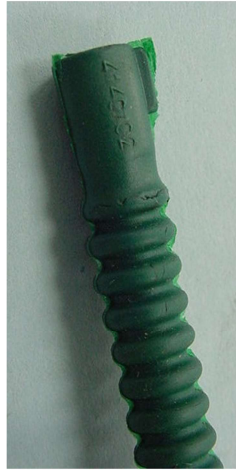
Molding Flaw Restricted Fuel Flow at WOT

This fuel line was installed on a BG 55 blower. The dealer stated that when it was set up, that it would start and idle fine, but would go lean at WOT. The carburetor was the first thing checked and no faults were found. By process of elimination it was discovered that the engine ran fine once the fuel line was replaced. The cut open end was at the carburetor fitting, and the flap of material flash would restrict fuel flow enough at WOT to cause the engine to run lean. This is a very rare fault and was challenging to locate but in some cases a process of elimination may be necessary to locate the fault.

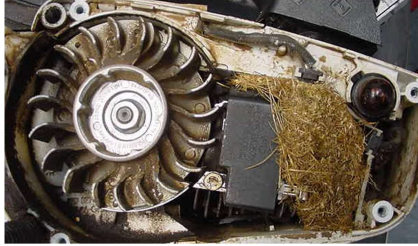
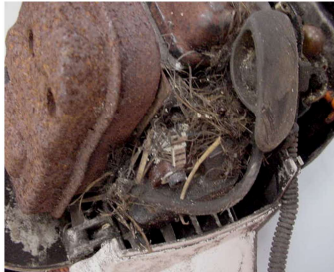
- Sometimes the reason for an overheating situation is obvious, sometimes it is not

The MS 192 in the upper picture was used to trim palm trees and the fine fibers completely blocked the airflow under the starter housing. This is a maintenance concern that is the operator's responsibility.

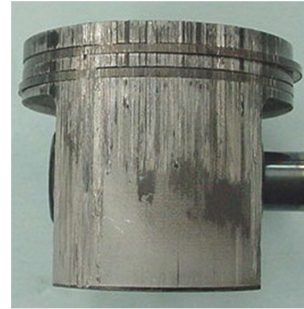
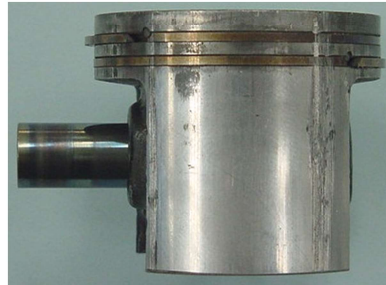
Black Underside of Piston
Wrist Pin Blue

Exhaust Scored Across Top, and to the Bottom at Ribs

Intake Scoring Top to Bottom at Ribs

This is another example of a saw that was overheated by the operator's long tailed shirt getting sucked up against the air intake on the starter housing, while he was limbing a fallen tree.

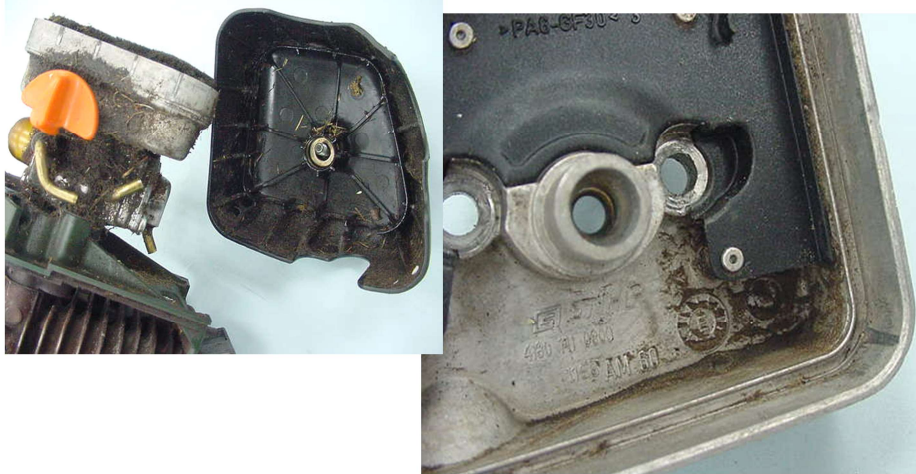
Dirt Ingestion**HT 100**

This is what the air filter box looked like when the element was removed. This pole saw was used in a logging yard to trim any branches hanging off of the truck after it was loaded. The loading area was just a dirt lot, with lots of dust being stirred up by the trucks and loaders. The operator would sit the pole saw on the ground, and leave it idling.

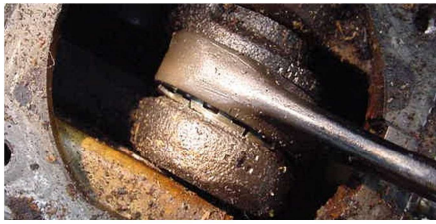
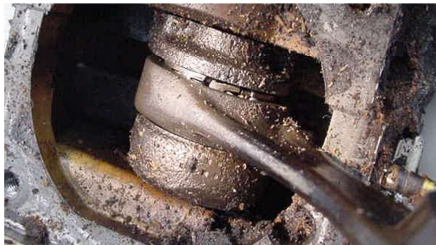
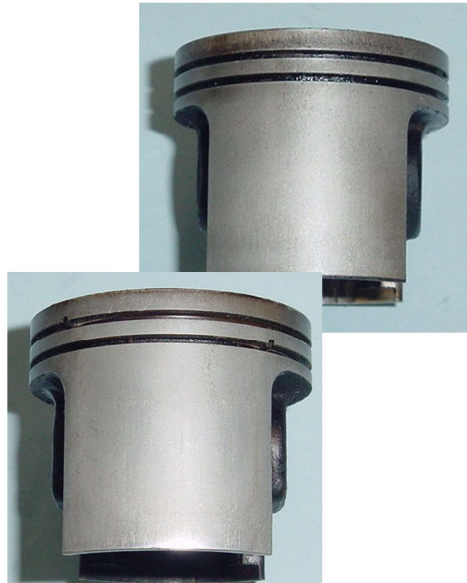
This engine had a considerable amount of run time on it, with evidence of long term dirt ingestion and very little maintenance. Notice how dull the piston surface is. There are no machine marks present on the piston. The needle cage is broken in several places on the big end of the connecting rod, due to the dirt ingestion and the piston being loose in the cylinder.

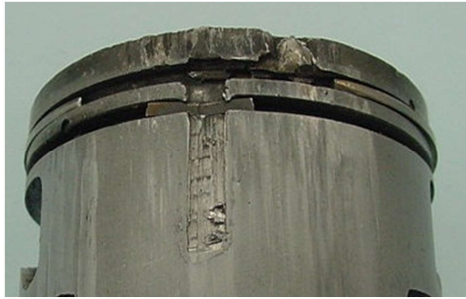
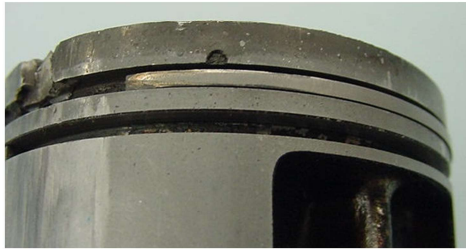
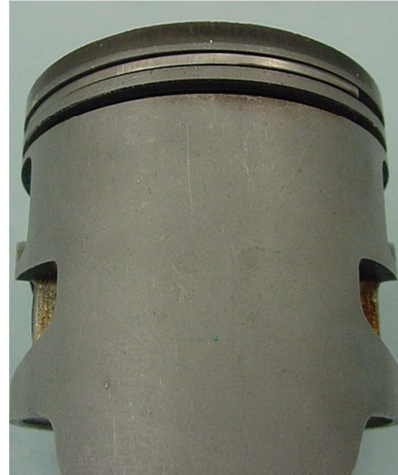
This TS 400 was used for five years by a stone mason for cutting decorative landscaping blocks. The long term ingestion of masonry dust wore the indexing pins that prevent the rings from rotating in the groove, as well as causing a considerable amount of wear to the rings and the piston. The pins were eventually worn away enough to allow the ring to rotate around and the end of the ring got caught in the exhaust port, causing the catastrophic damage that finally stopped the engine from running.

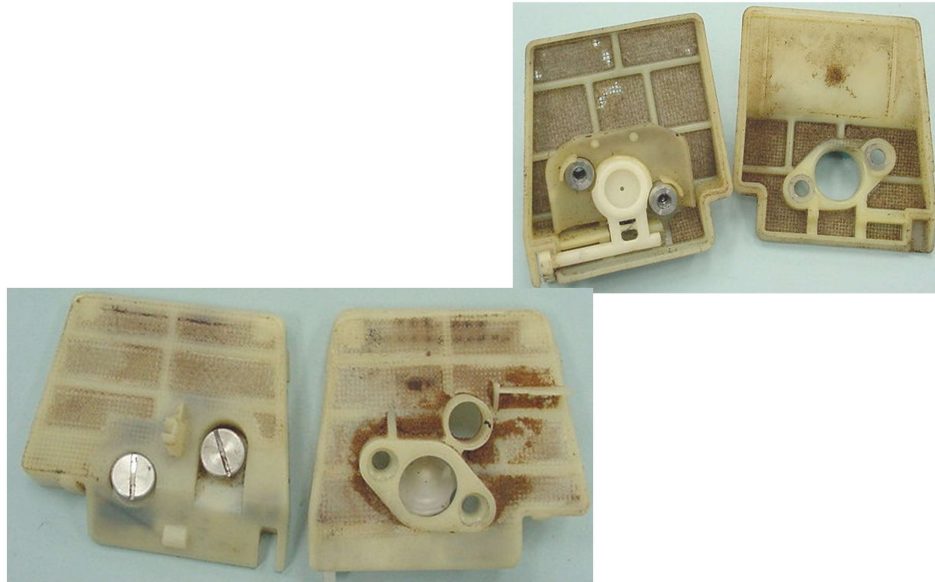
The nylon mesh filter on the left is not for dry, dusty cutting conditions. This filter is for wet, snowy, winter cutting, and is designed to help reduce icing in the carb. The operator will need to maintain the saw well, and prevent cutting dust from the bar and chain from accumulating. Wood dust will go through this element.

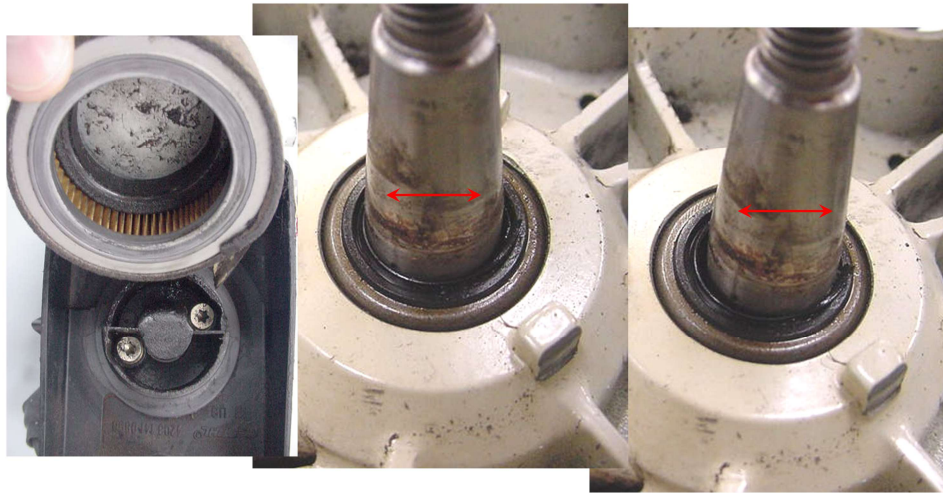
This BR 400 has three years of commercial run time on it. It has also suffered from a considerable amount of dirt ingestion due to lack of maintenance of the air filter.

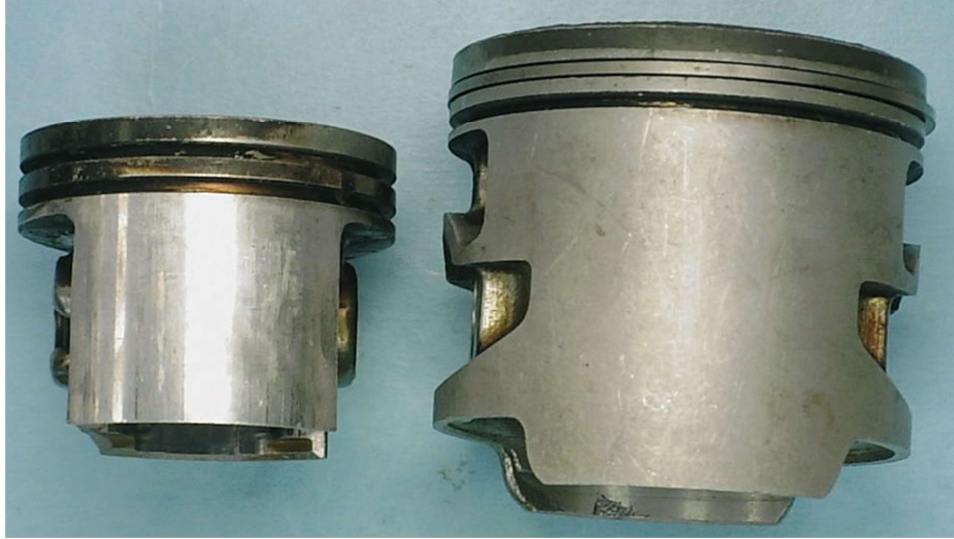
The piston on the right from a TS 420 is a good example of long term fine concrete dust ingestion. All the machine marks are worn away, the ring end gap is excessive, and even the dowel pins that prevent the rings from rotating are worn away which is why the engine finally failed, due to the ring clipping in a port.

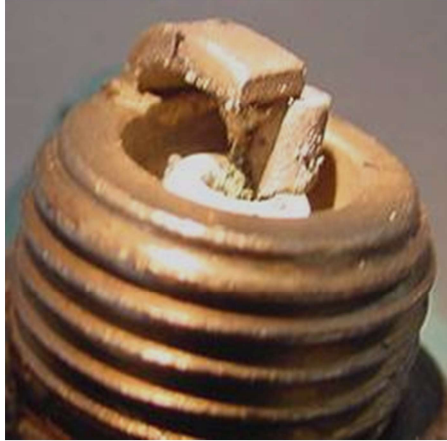
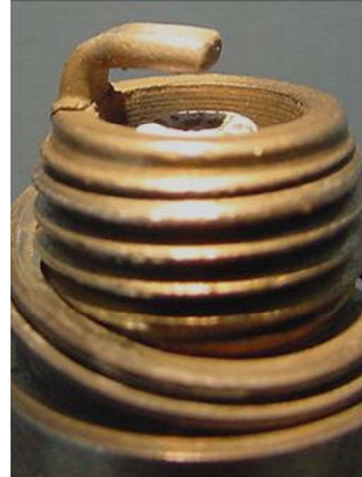
Spark plug heat range is very important to an engine. Always verify if the plug installed is the right one when doing an evaluation of an engine.

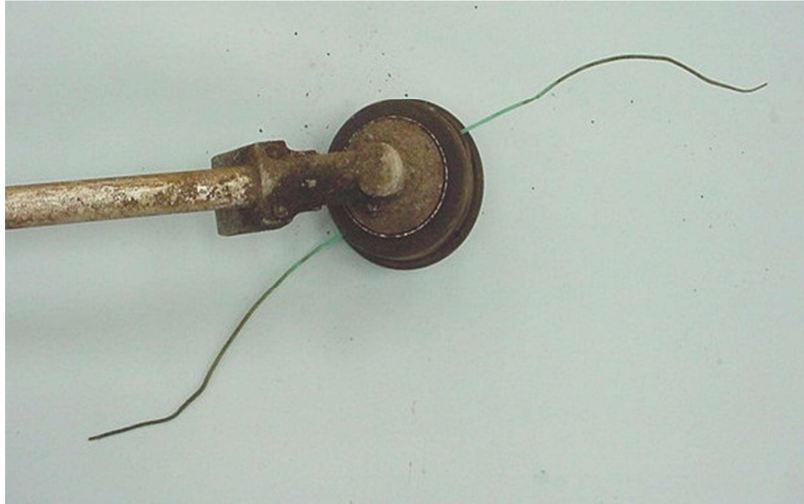
The deflector is necessary not only to provide some protection to the operator from thrown debris, but to limit the line length. Running the line longer than specification will drastically lower engine RPM, increase spark plug temperature, and increase fuel consumption and emissions.

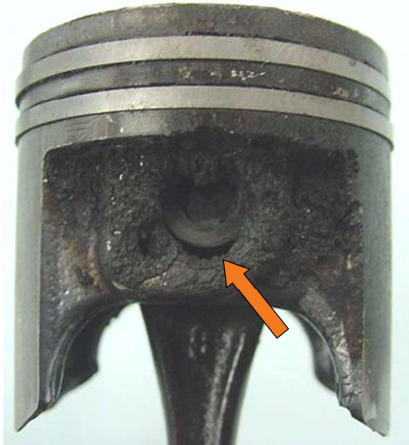
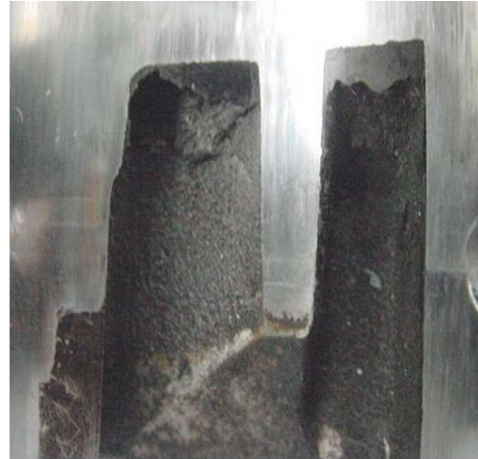
- Wrist Pin is Extremely Loose

This example is from a trimmer that was operated without a deflector so the line was too long, causing the engine to run well below its rated speed. The oil was also mixed too rich. The carbon buildup is so severe that it caused the wrist pin bore to wear and the piston is extremely loose. When the engine is lugged the temperature goes up, in some cases by as much as 100° F, which causes the oil to “coke” and burn, and creates the deposits seen here. The transfer ports are so clogged that the port timing has been changed: they now open late and close early. An air cooled engine needs to run at the rated speed to keep cool and be efficient. For a FS 80, the rated speed is around 9500 RPM.

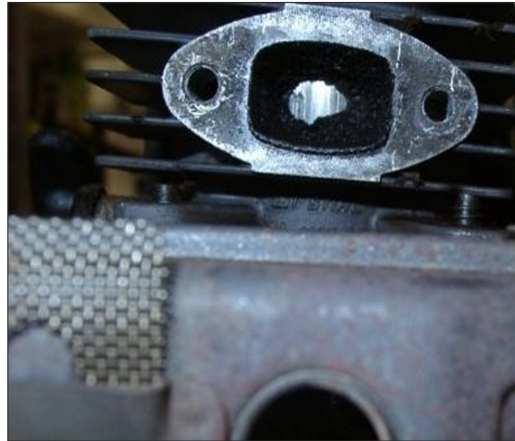
Exhaust port blockage can be caused by several factors, or a combination of things. Low quality fuel will cause carbon buildup. Stihl recommends 89 octane name brand fuel be used in all products. Mixing the oil too rich, or using a water cooled outboard oil or any oil not meant for mixing with fuel for air cooled engines can cause excessive and rapid carbon buildup.

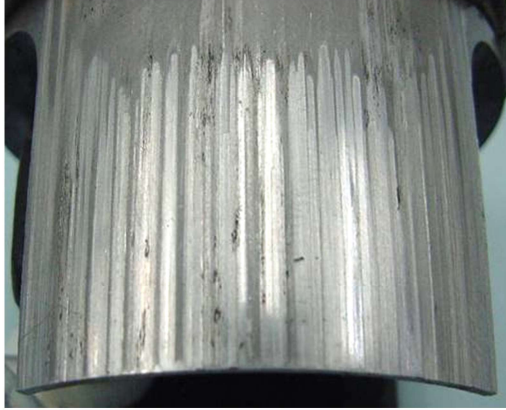
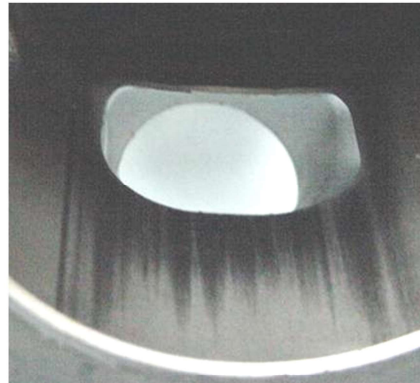
Water scoring will always be located on the intake side of piston.

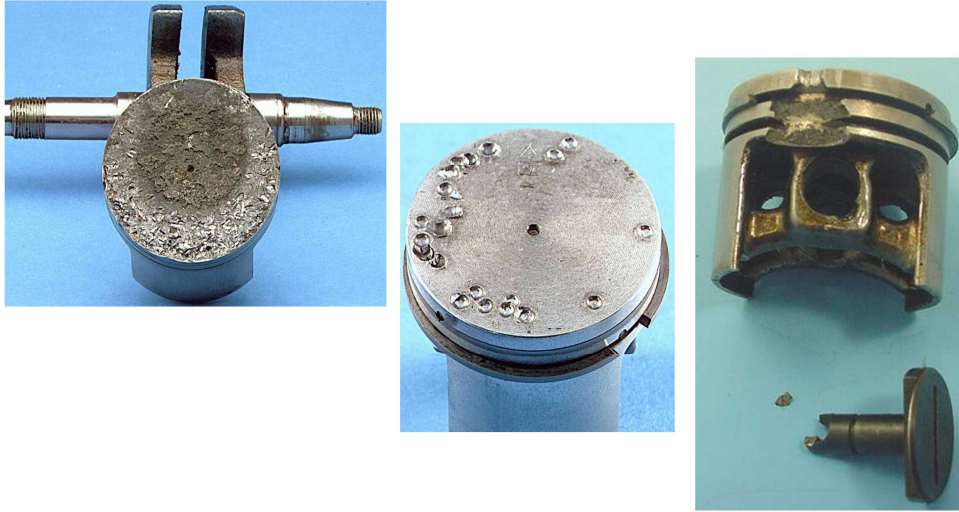
Often this kind of damage is mistaken for detonation, especially when the piston looks like the one on the left. Detonation will always be focused on the exhaust side of the piston, not all the way around the top. However, the damage may lead to sharp edges and hot spots that can cause pre-ignition and detonation, if the engine continues to run after the foreign object passes into the muffler or is ground up.
